Drainage Report

Milton Parking
Gas Road
Sittingbourne
Kent
ME10 2QB

Milton Parking Gas Road - CCTV Survey Report : 20/06/25

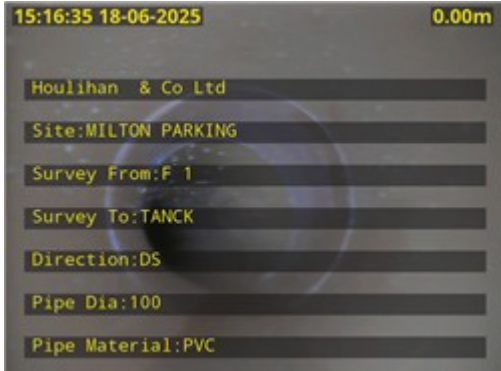
Pos	Video Ref	Code	Cont.	Description	Image
00.0m	0:00:00	MH		Start node type, manhole, reference F1 F1	<p>Image Provided - Ref: 0_0</p>

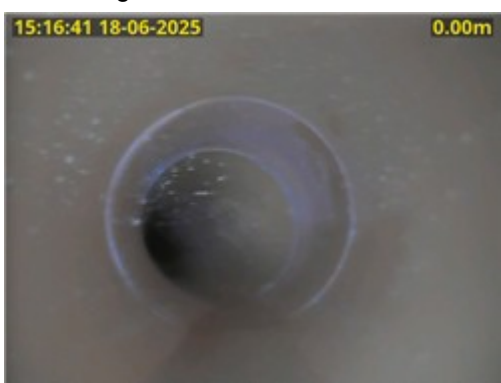
00.0m	0:00:00	WL		Water level: 0% Height/Diameter	<p>Image Provided - Ref: 0_1</p>

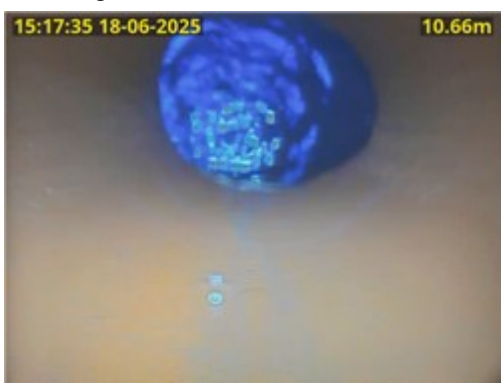
10.7m		MHF		Finish node type, manhole, reference Tank Tank	<p>Image Provided - Ref: 0_9999</p>

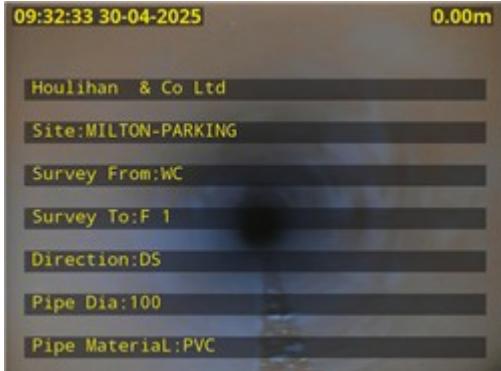
Pos	Video Ref	Code	Cont.	Description	Image
00.0m	0:00:00	MH		Start node type, manhole, reference WC WC	<p>Image Provided - Ref: 5_0</p>

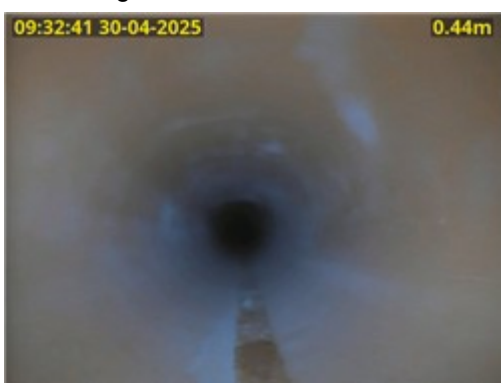
00.0m	0:00:00	WL		Water level: 0% Height/Diameter	<p>Image Provided - Ref: 5_1</p>

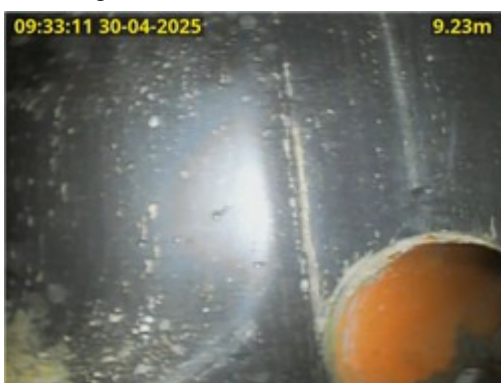
09.2m		MHF		Finish node type, manhole, reference F1 F1	<p>Image Provided - Ref: 5_9999</p>

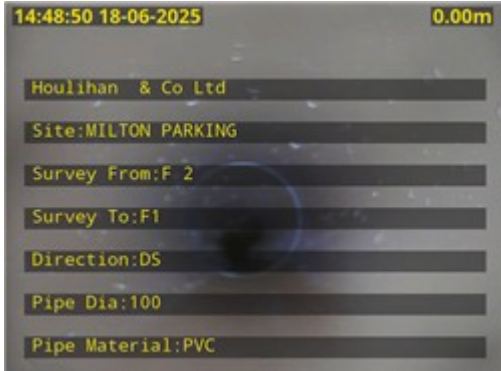
Pos	Video Ref	Code	Cont.	Description	Image
00.0m	0:00:00	MH		Start node type, manhole, reference F2 F2	<p>Image Provided - Ref: 1_0</p>

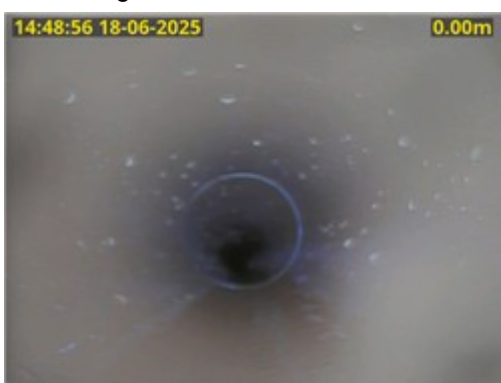
00.0m	0:00:00	WL		Water level: 0% Height/Diameter	<p>Image Provided - Ref: 1_1</p>

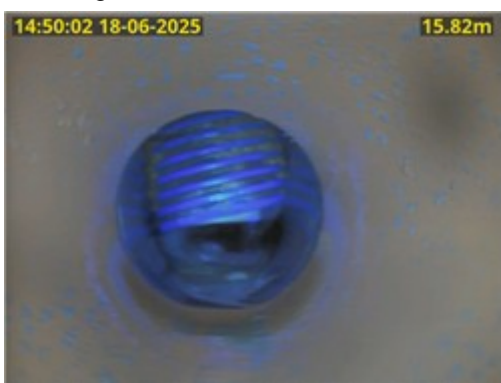
15.8m		MHF		Finish node type, manhole, reference F1 F1	<p>Image Provided - Ref: 1_9999</p>

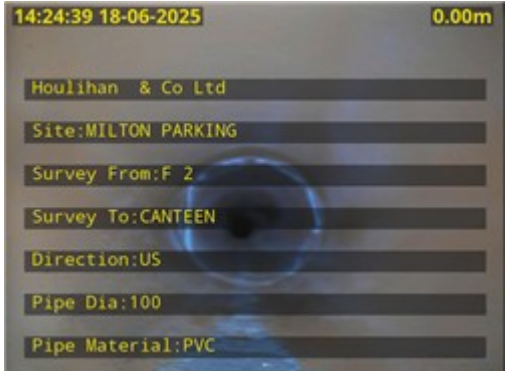
Pos	Video Ref	Code	Cont.	Description	Image
00.0m	0:00:00	MH		Start node type, manhole, reference F2 F2	<p>Image Provided - Ref: 2_0</p>

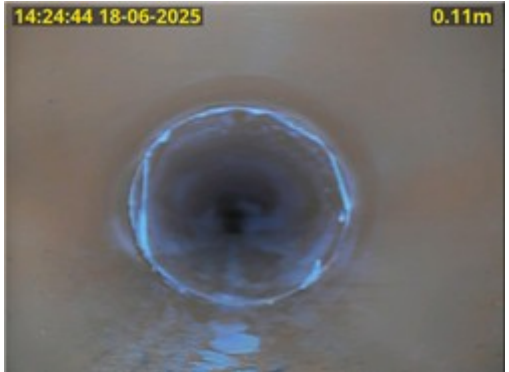
00.0m	0:00:00	WL		Water level: 0% Height/Diameter	<p>Image Provided - Ref: 2_1</p>

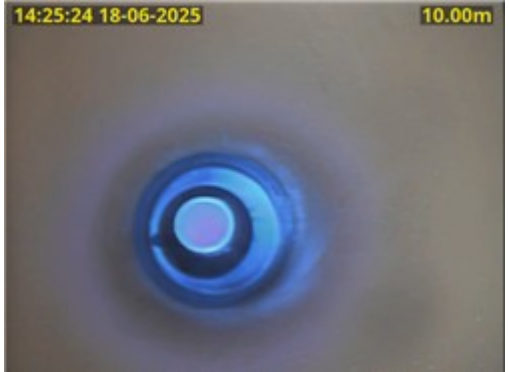
00.0m		MHF		Finish node type, manhole, reference Canteen Reached Outlet for Canteen	<p>Image Provided - Ref: 2_9999</p>

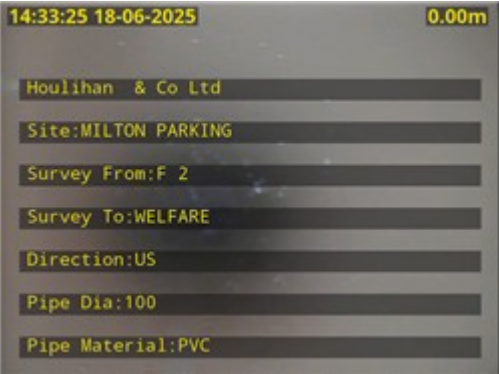
Pos	Video Ref	Code	Cont.	Description	Image
00.0m	0:00:00	MH		Start node type, manhole, reference F2 F2	<p>Image Provided - Ref: 3_0</p>

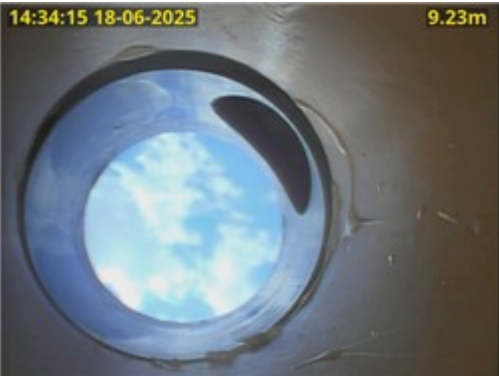
09.2m		MHF		Finish node type, manhole, reference Welfare Welfare	<p>Image Provided - Ref: 3_9999</p>

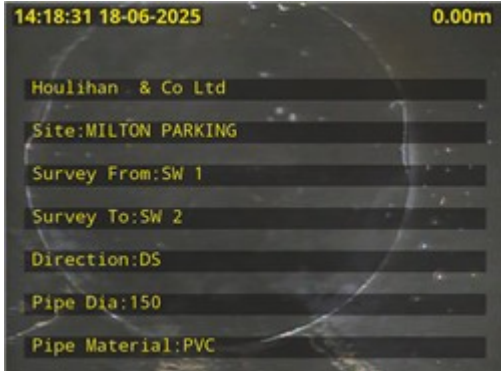
Pos	Video Ref	Code	Cont.	Description	Image
00.0m	0:00:00	MH		Start node type, manhole, reference SW 1 SW2	<p>Image Provided - Ref: 4_0</p>

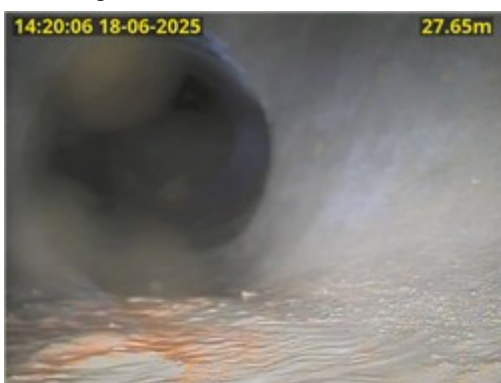
27.7m		MHF		Finish node type, manhole, reference SW 2 SW1	<p>Image Provided - Ref: 4_9999</p>

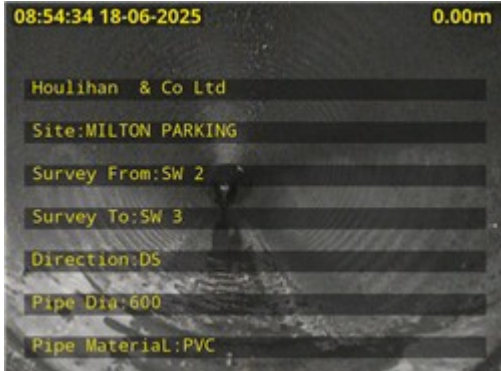
Pos	Video Ref	Code	Cont.	Description	Image
00.0m	0:00:00	MH		Start node type, manhole, reference SW 2 SW 2	<p>Image Provided - Ref: 6_0</p>

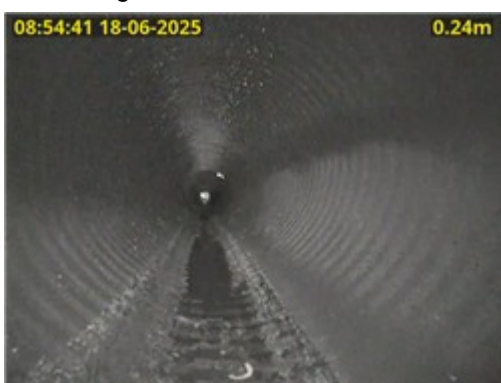
00.0m	0:00:00	WL		Water level: 0% Height/Diameter	<p>Image Provided - Ref: 6_1</p>

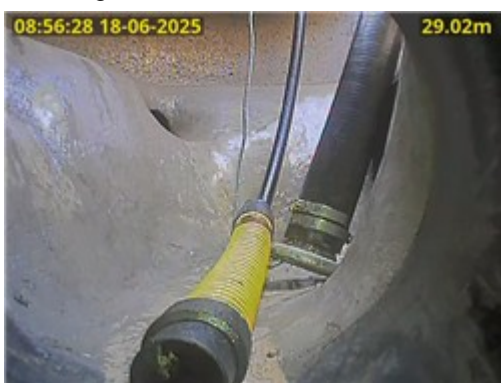
29.0m		MHF		Finish node type, manhole, reference SW 3 SW 3	<p>Image Provided - Ref: 6_9999</p>

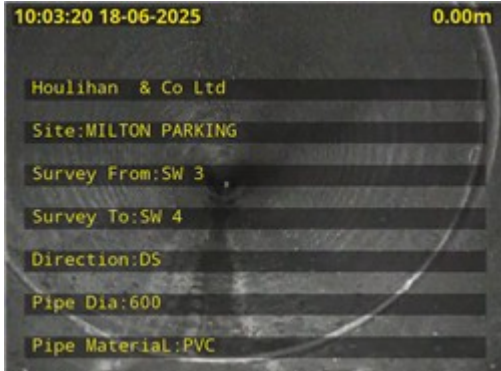
Pos	Video Ref	Code	Cont.	Description	Image
00.0m	0:00:00	MH		Start node type, manhole, reference SW 3 SW 3	<p>Image Provided - Ref: 7_0</p>

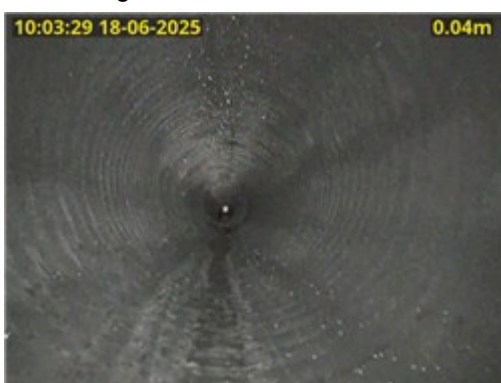
00.0m	0:00:00	WL		Water level: 0% Height/Diameter	<p>Image Provided - Ref: 7_1</p>

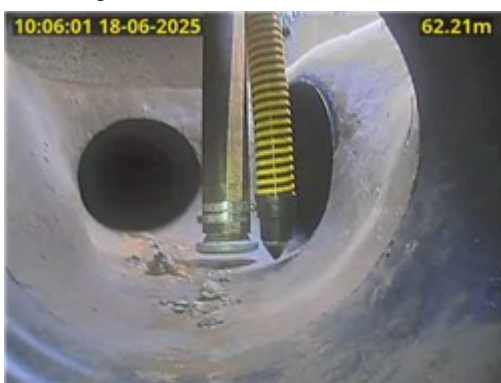
62.2m		MHF		Finish node type, manhole, reference SW 4 SW 4	<p>Image Provided - Ref: 7_9999</p>

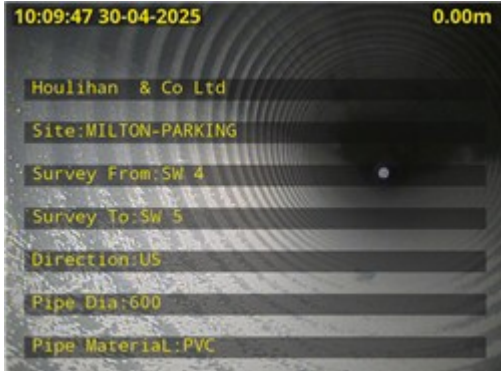
Pos	Video Ref	Code	Cont.	Description	Image
00.0m	0:00:00	MH		Start node type, manhole, reference SW 4 SW 4	<p>Image Provided - Ref: 8_0</p>

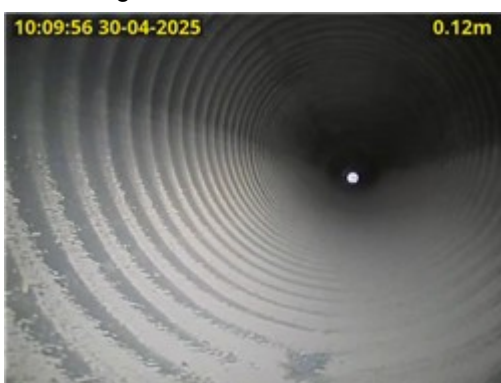
00.0m	0:00:00	WL		Water level: 0% Height/Diameter	<p>Image Provided - Ref: 8_1</p>

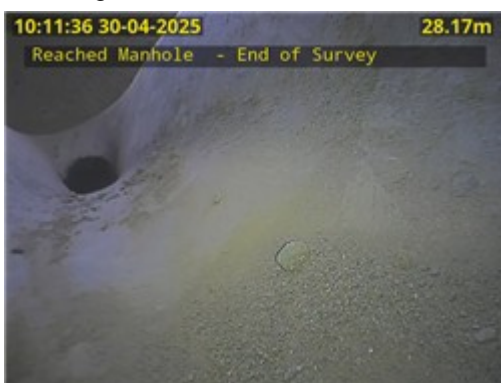
27.6m		MHF		Finish node type, manhole, reference SW 5 SW 5	<p>Image Provided - Ref: 8_9999</p>

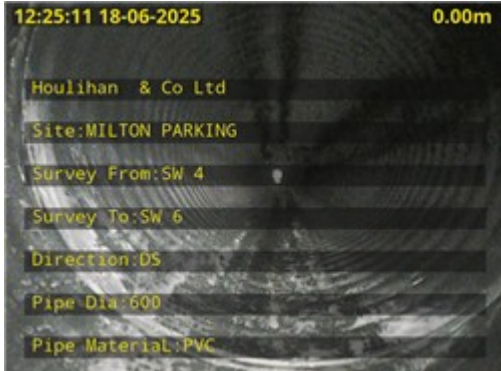
Pos	Video Ref	Code	Cont.	Description	Image
00.0m	0:00:00	MH		Start node type, manhole, reference SW 4 SW 4	<p>Image Provided - Ref: 9_0</p>

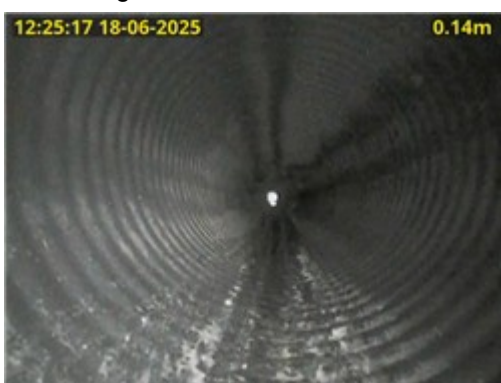
00.0m	0:00:00	WL		Water level: 0% Height/Diameter	<p>Image Provided - Ref: 9_1</p>

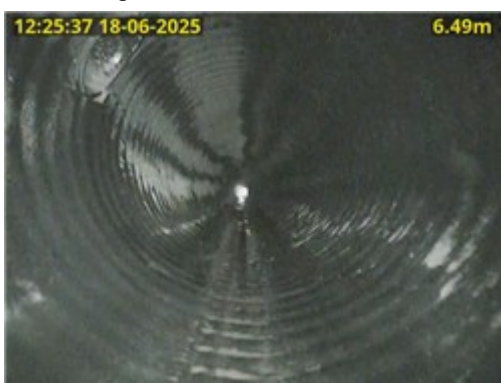
06.4m	0:00:25	CN		Connection other than junction at 10 o'clock: 150mm Diameter	<p>Image Provided - Ref: 9_2</p>

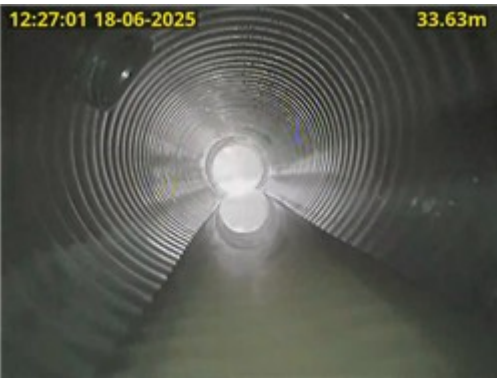
Pos	Video Ref	Code	Cont.	Description	Image
33.6m	0:01:49	CN		Connection other than junction at 10 o'clock: 150mm Diameter	<p>Image Provided - Ref: 9_3</p>

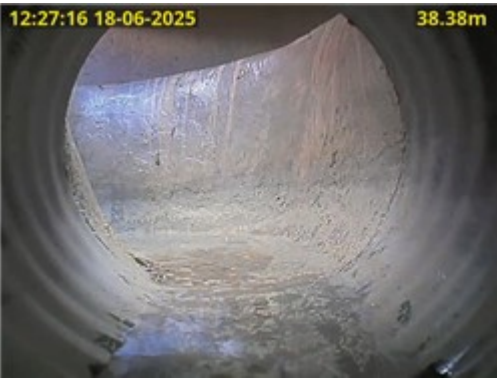
38.4m		MHF		Finish node type, manhole, reference SW 6 SW 6	<p>Image Provided - Ref: 9_9999</p>

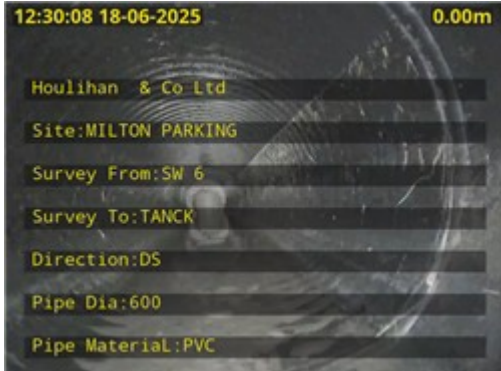
Pos	Video Ref	Code	Cont.	Description	Image
00.0m	0:00:00	MH		Start node type, manhole, reference SW 6 SW 6	<p>Image Provided - Ref: 10_0</p>

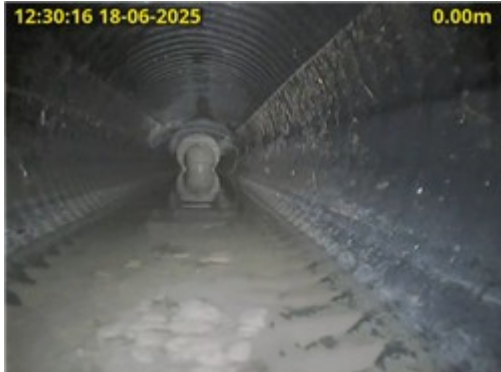
00.0m	0:00:00	WL		Water level: 0% Height/Diameter	<p>Image Provided - Ref: 10_1</p>

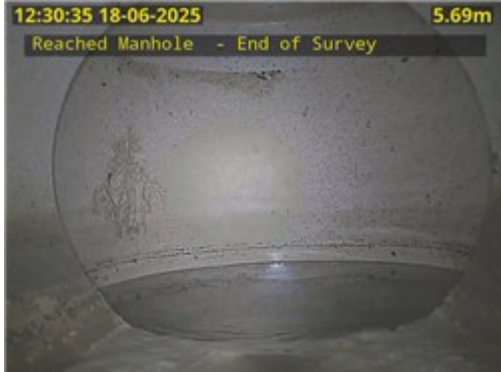
05.7m		MHF		Finish node type, manhole, reference Tank Tank	<p>Image Provided - Ref: 10_9999</p>

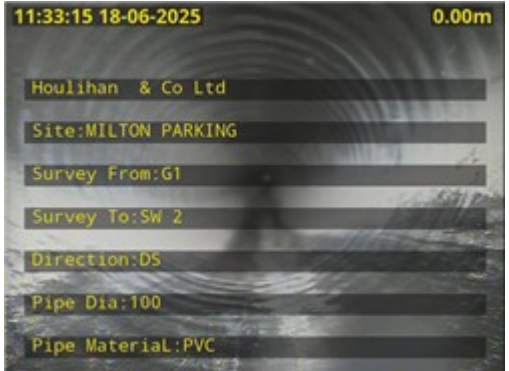
Pos	Video Ref	Code	Cont.	Description	Image
00.0m	0:00:00	MH		Start node type, manhole, reference Gully 1	<p>Image Provided - Ref: 11_0</p>

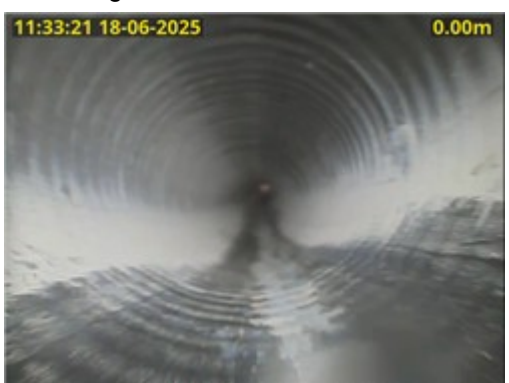
00.0m	0:00:00	WL		Water level: 0% Height/Diameter	<p>Image Provided - Ref: 11_1</p>

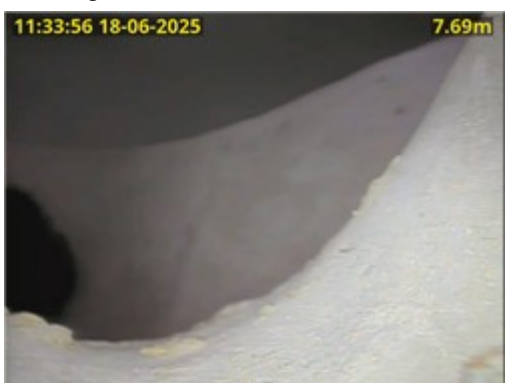
07.7m		MHF		Finish node type, manhole, reference SW 2	<p>Image Provided - Ref: 11_9999</p>

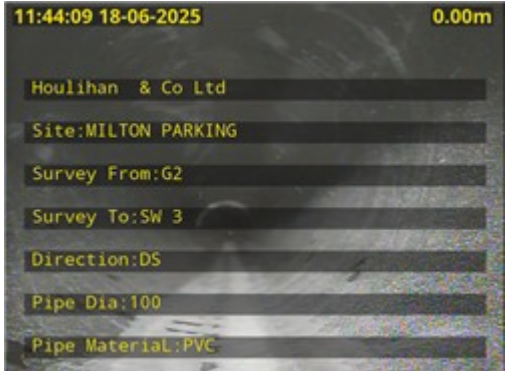
Pos	Video Ref	Code	Cont.	Description	Image
00.0m	0:00:00	MH		Start node type, manhole, reference Gully 2	<p>Image Provided - Ref: 12_0</p>

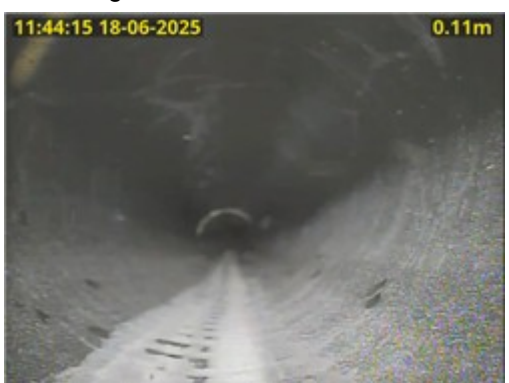
00.0m	0:00:00	WL		Water level: 0% Height/Diameter	<p>Image Provided - Ref: 12_1</p>

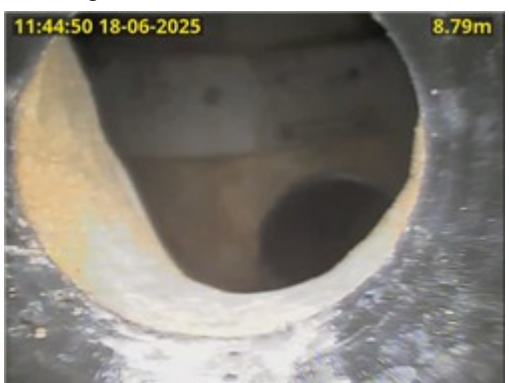
08.8m		MHF		Finish node type, manhole, reference SW 3	<p>Image Provided - Ref: 12_9999</p>

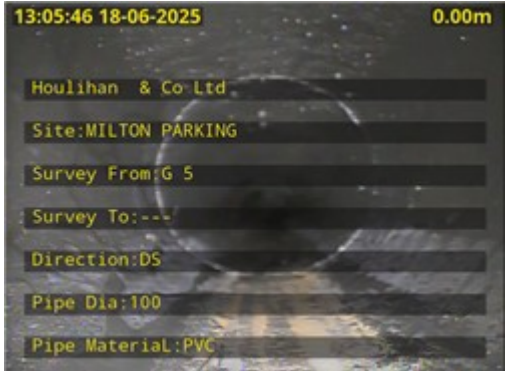
Pos	Video Ref	Code	Cont.	Description	Image
00.0m	0:00:00	MH		Start node type, manhole, reference Gully 5	<p>Image Provided - Ref: 13_0</p>

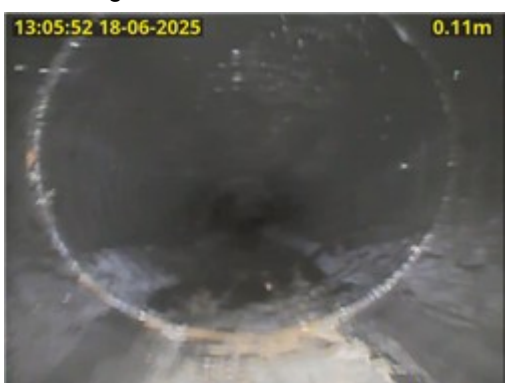
00.0m	0:00:00	WL		Water level: 0% Height/Diameter	<p>Image Provided - Ref: 13_1</p>

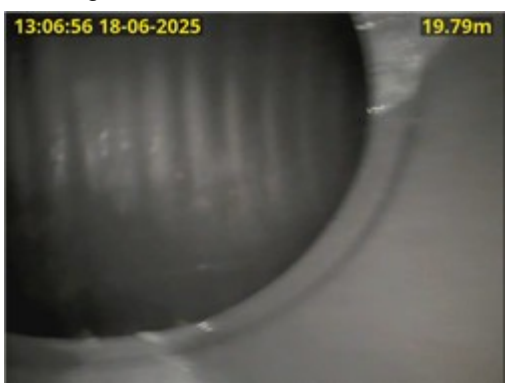
19.8m		MHF		Finish node type, manhole, reference DS of SW 4	<p>Image Provided - Ref: 13_9999</p>

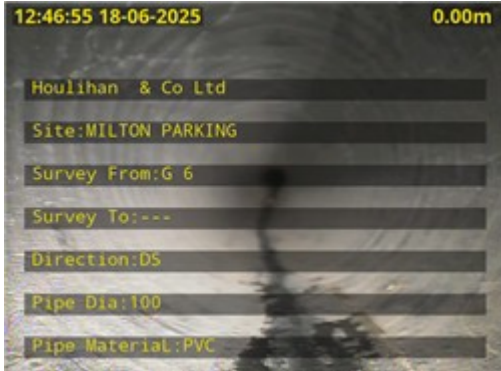
Pos	Video Ref	Code	Cont.	Description	Image
00.0m	0:00:00	MH		Start node type, manhole, reference Gully 6	<p>Image Provided - Ref: 14_0</p>

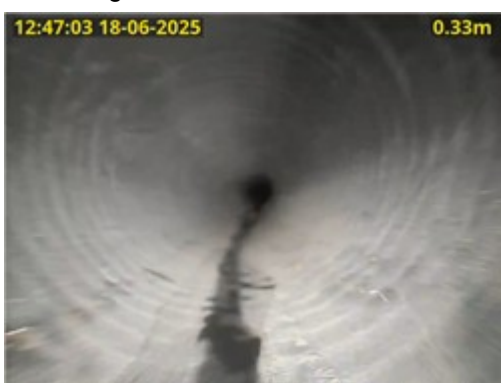
00.0m	0:00:00	WL		Water level: 0% Height/Diameter	<p>Image Provided - Ref: 14_1</p>

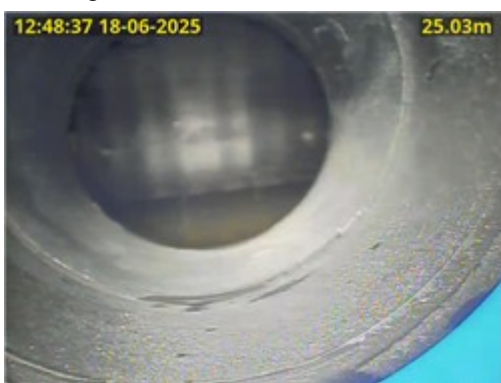
25.0m		MHF		Finish node type, manhole, reference DS of SW 4	<p>Image Provided - Ref: 14_9999</p>

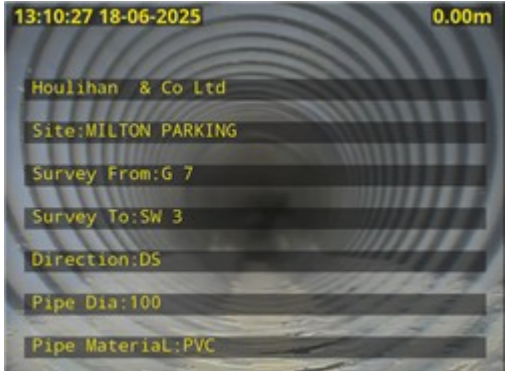
Pos	Video Ref	Code	Cont.	Description	Image
00.0m	0:00:00	MH		Start node type, manhole, reference Gully 7	<p>Image Provided - Ref: 15_0</p>

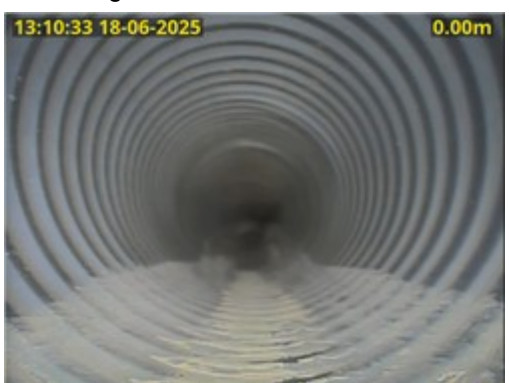
00.0m	0:00:00	WL		Water level: 0% Height/Diameter	<p>Image Provided - Ref: 15_1</p>
