Drainage Report

Clarus Homes
Bears Green Plot 2 - Bears Lane
Great Chart, Bethersden, Ashford
Kent
TN23 3BZ

Clarus Homes Bears Lane PLOT 2 - CCTV Survey Report : 10/07/25

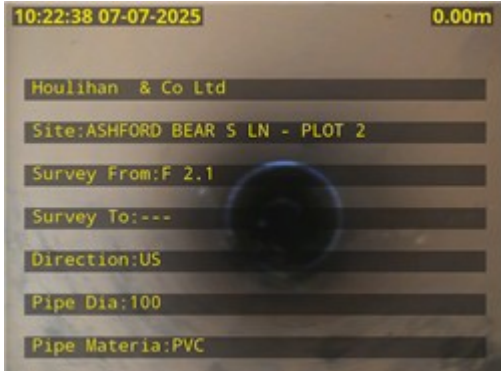
Pos	Video Ref	Code	Cont.	Description	Image
00.0m	0:00:00	MH		Start node type, manhole, reference F2.1 F2.1	<p>Image Provided - Ref: 0_0</p>

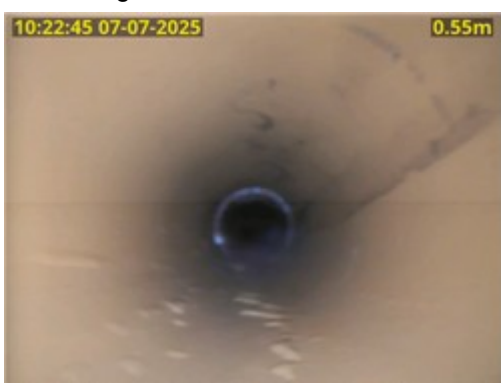
00.0m	0:00:00	WL		Water level: 0% Height/Diameter	<p>Image Provided - Ref: 0_1</p>

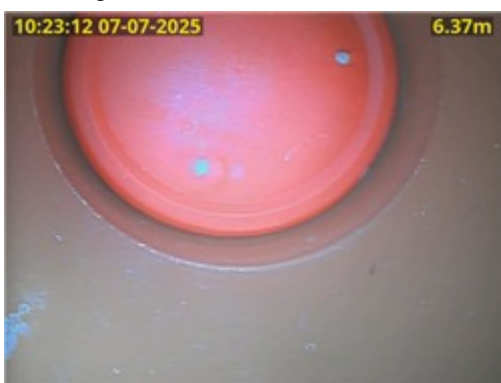
06.4m		MHF		Finish node type, manhole, reference Kitchen/Cap Reached Kitchen/Capped Off	<p>Image Provided - Ref: 0_9999</p>

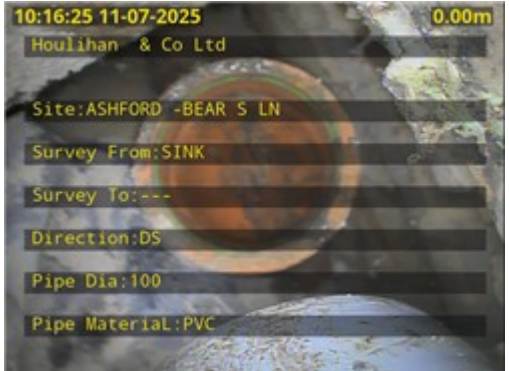
Pos	Video Ref	Code	Cont.	Description	Image
00.0m	0:00:00	OF		Start node type, outfall, reference Kitchen Waste Kitchen Waste	<p>Image Provided - Ref: 7_0</p>

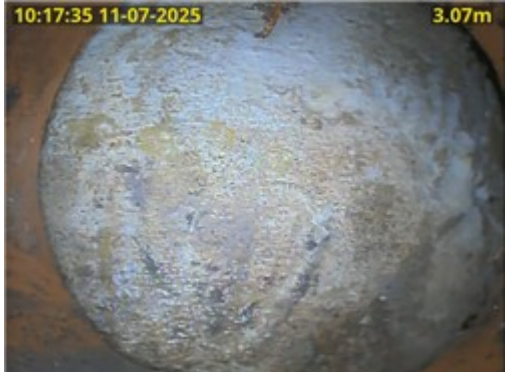
00.0m	0:00:00	WL		Water level: 0% Height/Diameter	
03.1m		MHF		Finish node type, manhole, reference F2.1 F2.1	<p>Image Provided - Ref: 7_9999</p>

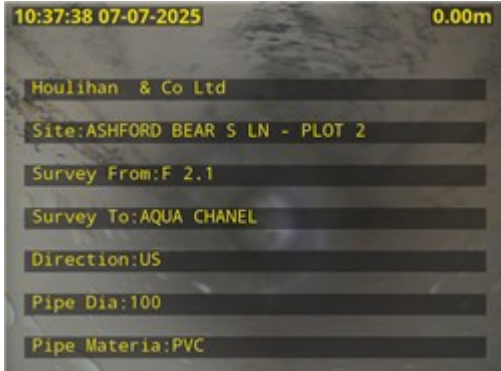
Pos	Video Ref	Code	Cont.	Description	Image
00.0m	0:00:00	MH		Start node type, manhole, reference F2.1 F2.1	<p>Image Provided - Ref: 1_0</p>

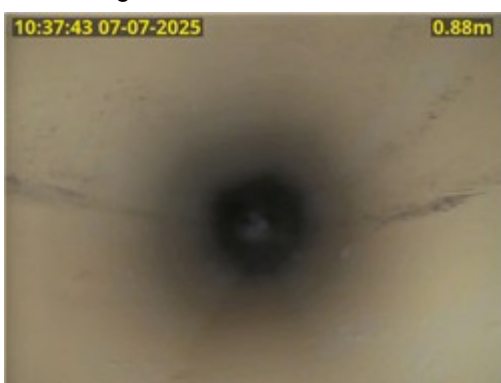
00.0m	0:00:00	WL		Water level: 0% Height/Diameter	<p>Image Provided - Ref: 1_1</p>

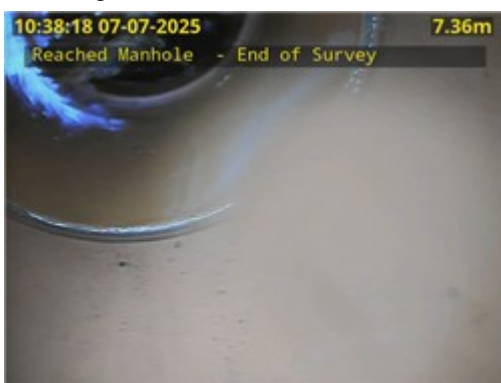
07.4m		GYF		Finish node type Gully, reference FW Gully Reached External FW Gully	<p>Image Provided - Ref: 1_9999</p>

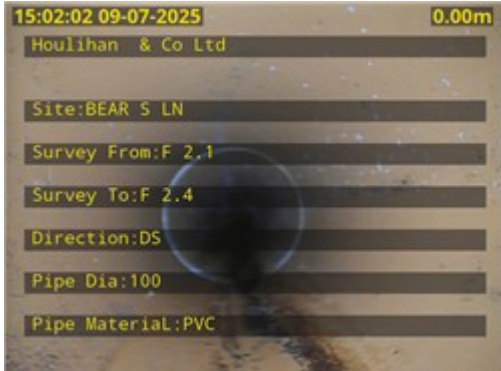
Pos	Video Ref	Code	Cont.	Description	Image
00.0m	0:00:00	MH		Start node type, manhole, reference F2.1 F2.1	<p>Image Provided - Ref: 2_0</p>

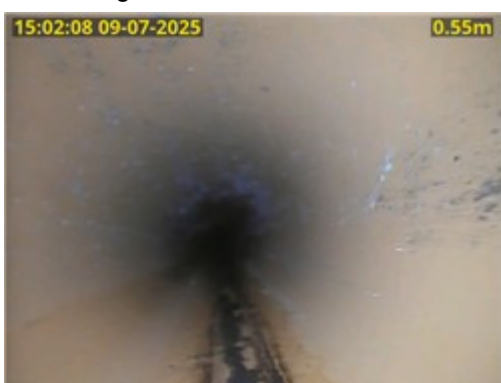
00.0m	0:00:00	WL		Water level: 0% Height/Diameter	<p>Image Provided - Ref: 2_1</p>

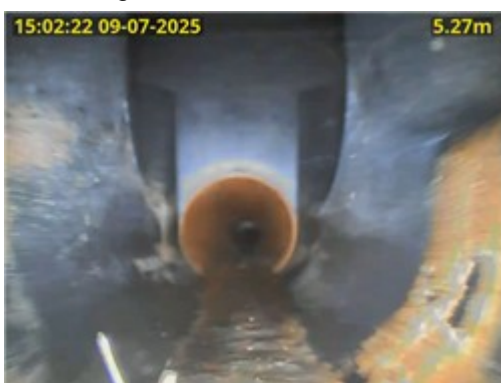
05.2m	0:00:20	REM		General remark Enters MH 2.2	<p>Image Provided - Ref: 2_2</p>

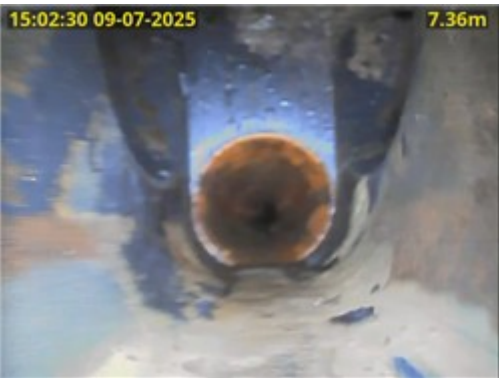
Pos	Video Ref	Code	Cont.	Description	Image
07.3m	0:00:28	REM		General remark Enters MH 2.3	<p>Image Provided - Ref: 2_3</p>

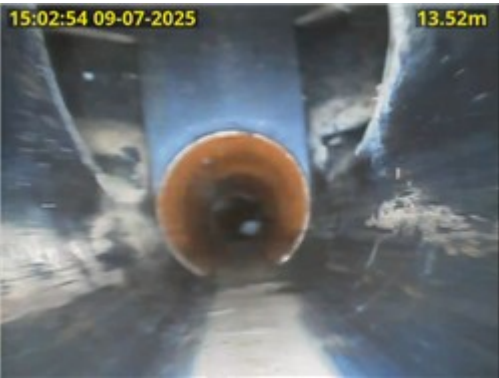
13.5m	0:00:52	REM		General remark Enter MH 2.4	<p>Image Provided - Ref: 2_4</p>

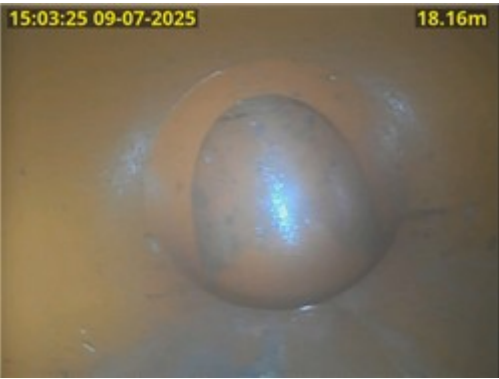
18.2m		MHF		Finish node type, manhole, reference Treatment Plant Treatment Plant	<p>Image Provided - Ref: 2_9999</p>

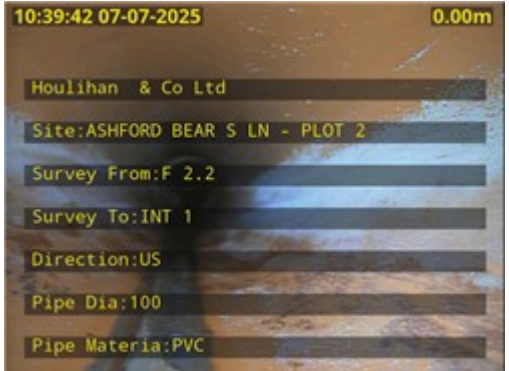
Pos	Video Ref	Code	Cont.	Description	Image
00.0m	0:00:00	MH		Start node type, manhole, reference F2.2 F2.2	<p>Image Provided - Ref: 3_0</p>

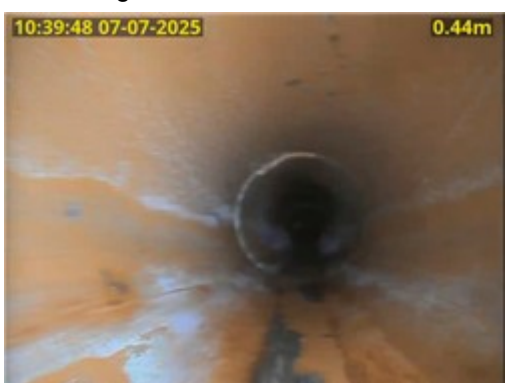
00.0m	0:00:00	WL		Water level: 0% Height/Diameter	<p>Image Provided - Ref: 3_1</p>

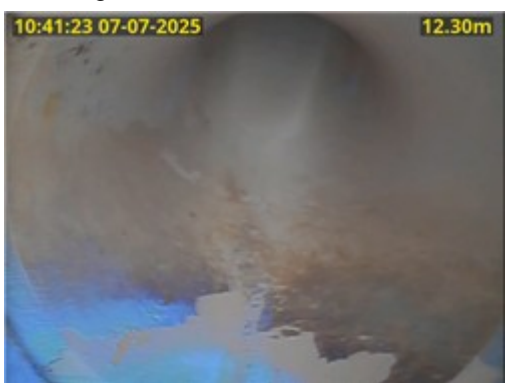
12.3m		MHF		Finish node type, manhole, reference Internal 1 Reached SVP Kitchen	<p>Image Provided - Ref: 3_9999</p>

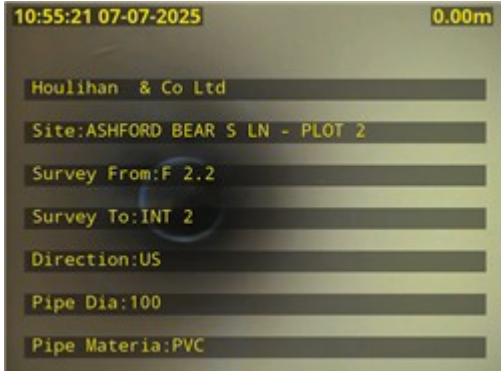
Pos	Video Ref	Code	Cont.	Description	Image
00.0m	0:00:00	MH		Start node type, manhole, reference F2.2 F2.2	<p>Image Provided - Ref: 4_0</p>

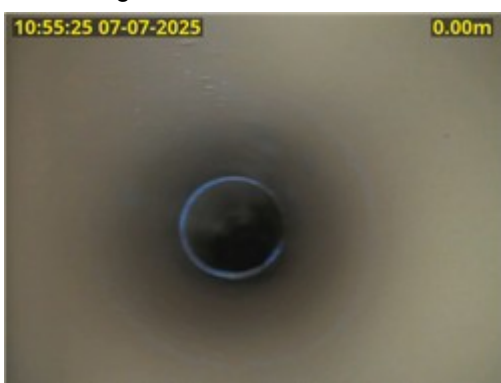
00.0m	0:00:00	WL		Water level: 0% Height/Diameter	<p>Image Provided - Ref: 4_1</p>

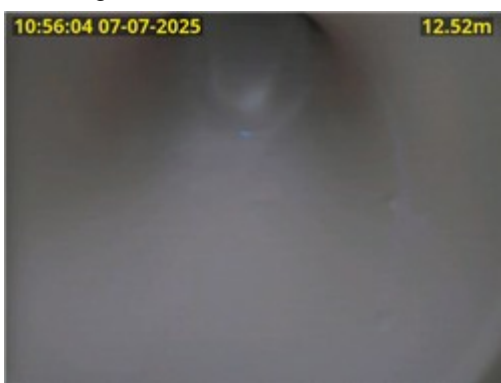
12.6m		BRF		Finish node type, major connection without manhole, reference Internal 2 Reached SVP Utility	<p>Image Provided - Ref: 4_9999</p>

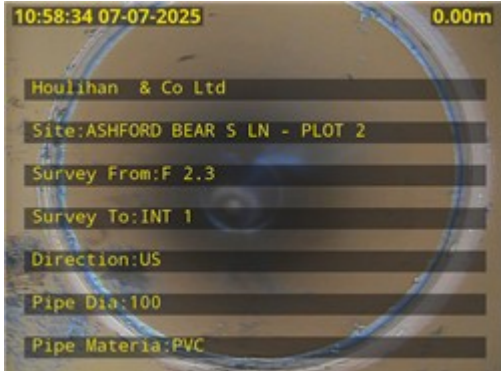
Pos	Video Ref	Code	Cont.	Description	Image
00.0m	0:00:00	MH		Start node type, manhole, reference F2.3 F2.3	<p>Image Provided - Ref: 5_0</p>

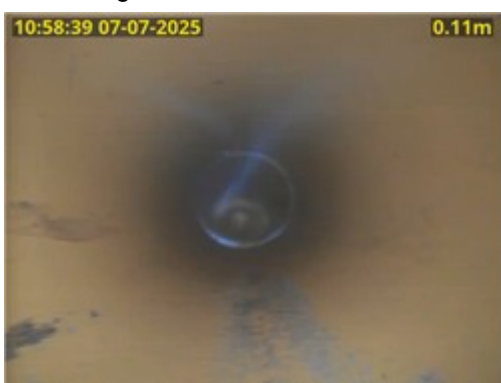
00.0m	0:00:00	WL		Water level: 0% Height/Diameter	<p>Image Provided - Ref: 5_1</p>

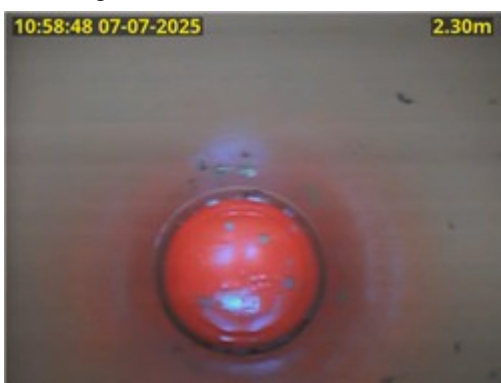
02.3m		MHF		Finish node type, manhole, reference Internal 3 Internal 3 - Capped off	<p>Image Provided - Ref: 5_9999</p>

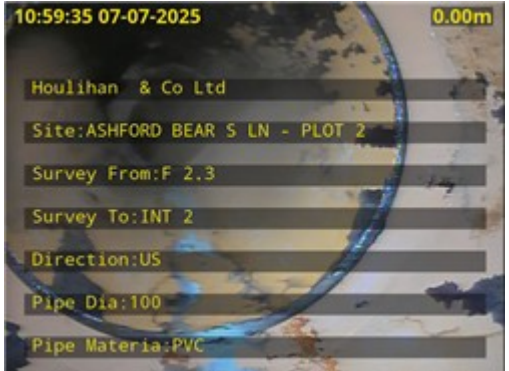
Pos	Video Ref	Code	Cont.	Description	Image
00.0m	0:00:00	MH		Start node type, manhole, reference F2.3 F2.3	<p>Image Provided - Ref: 6_0</p>

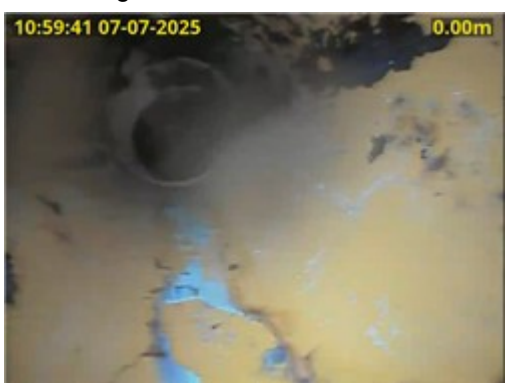
00.0m	0:00:00	WL		Water level: 0% Height/Diameter	<p>Image Provided - Ref: 6_1</p>
