Trade Talks Programme

**Foundations, ground
floors and drainage**

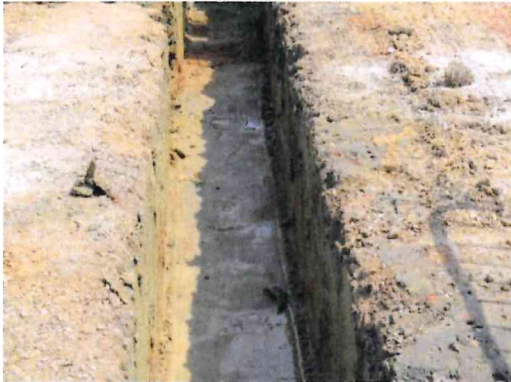
Strip/Trench Foundations - Terminology

- ✓ Strip foundations should be 150mm to 500mm thick (*T*)
- ✓ Trench fill foundations should be greater than 500mm thick (*T*)

- ✓ External walls
- ✓ Separating walls
- ✓ Chimney breasts
- ✓ Piers
- ✓ Internal load bearing walls
- ✓ Sleeper walls (Scotland)

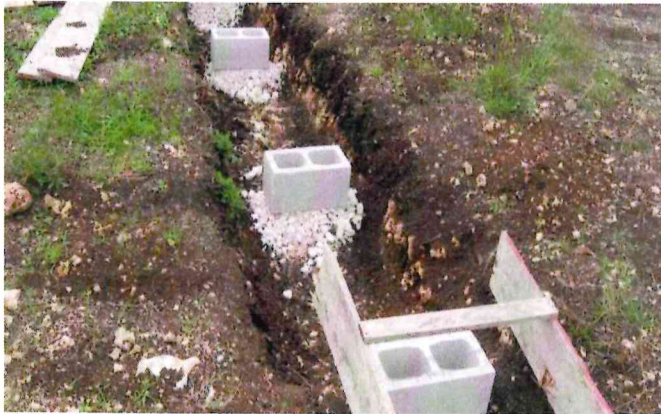
Key issues

- Insufficient foundation depth
- Suitable bearing strata not found
- Insufficient concrete depth

- Structural performance not achieved
- Foundation Failure
- Defects built-in

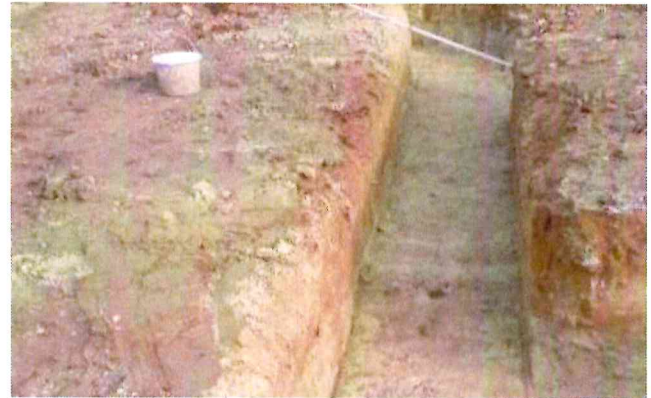
- Follow the design/details
- Changes in foundation design can only be made by the designer
- Ensure that any minimum foundation depths requirements are achieved
- Use a suitable working practice to indicate the finished concrete level

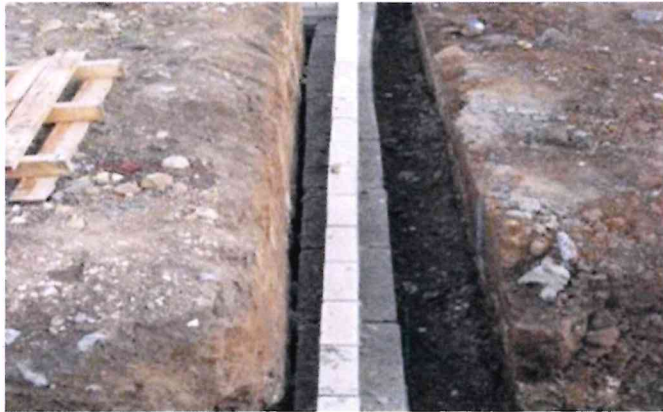
Key issues

- Poor workmanship
- Inaccurate setting out of foundation
- Point loading on to foundation

- Structural performance not achieved
- Disproportionate loads
- Potential foundation failure

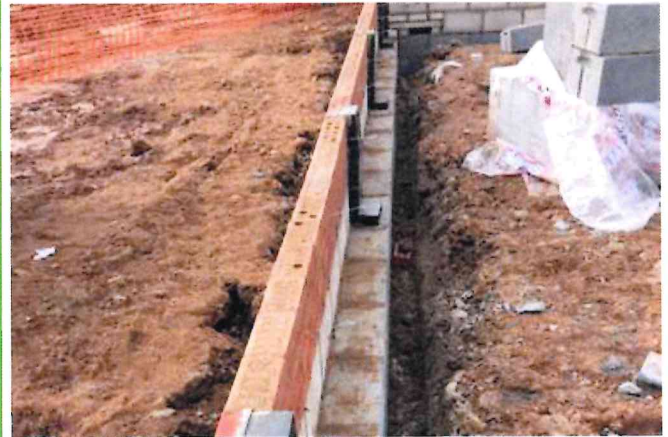
- Set out accurately
- With foundation excavations both line and level are important
- Ensure that the excavation follows the setting out
- Make suitable checks during and after the excavation activity

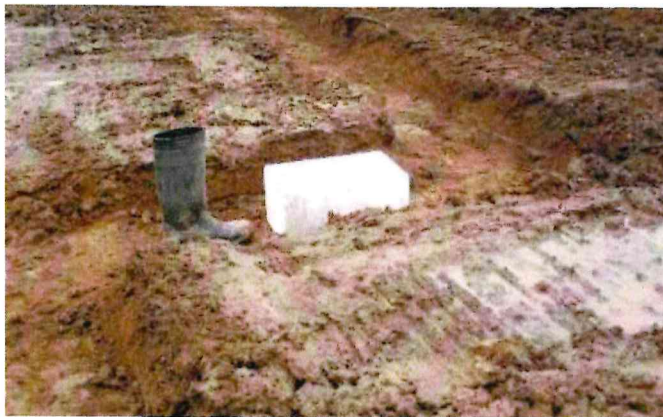
- Lack of Information may cause delays
- Inaccurate foundation depth
- Risk of failure increased

- Structural performance not achieved
- Desiccation of soil
- Potential foundation failure

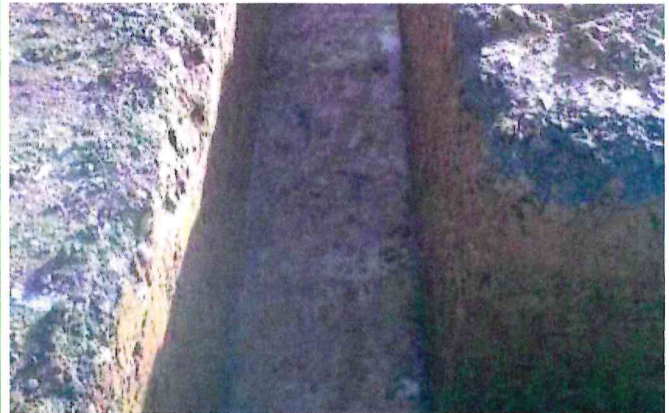
Modified Plasticity Index	Volume Change Potential	Minimum Depth (m)
40% and greater	High	1.0
20% to less than 40%	Medium	0.9
10% to less than 20%	Low	0.75

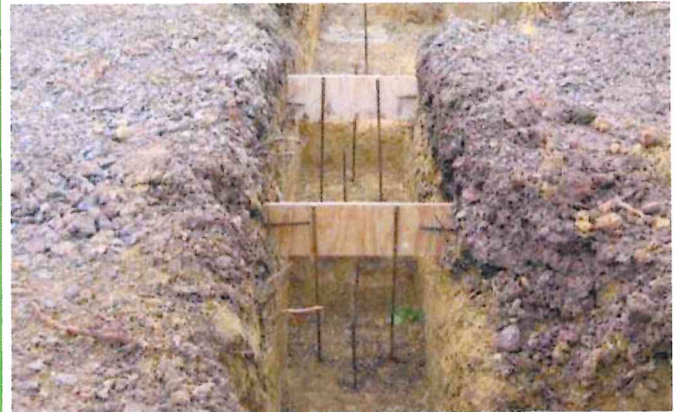
- Foundation bottoms should be horizontal
- Step faces should be as near vertical as possible
- Ensure that the step height does not exceed the foundation thickness
- Remove all formwork before commencing the substructure

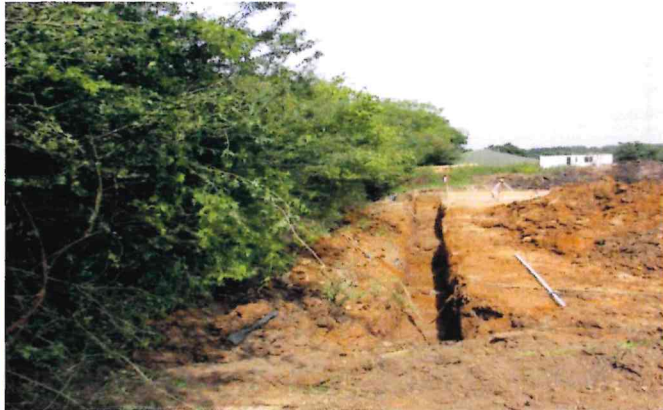
- High risk of heave/shrinkage
- Foundation failure
- Lack of suitable design

- Structural performance not achieved
- Risk of foundation failure due to heave/shrinkage of clay soils
- Disruption of homeowner

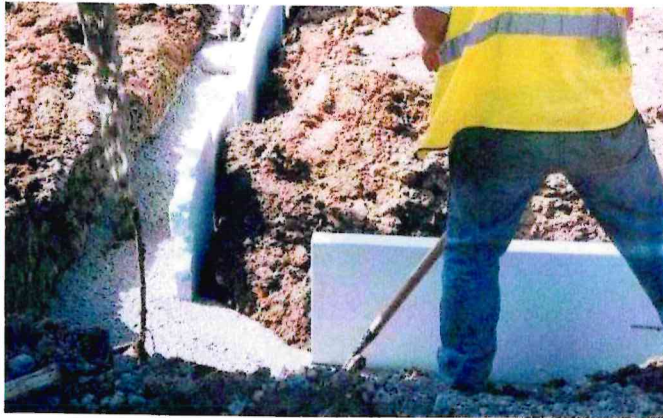
- Design not followed
- Precautions required to the inside leaf of the external wall in foundations
- Precautions must be continuous

- Compressible material suitability or incorrectly positioned impairing heave protection
- Risk of foundation failure

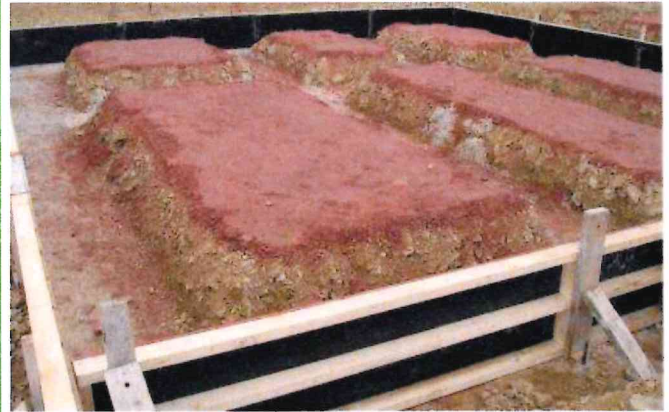
- If doubt exists with the formation consistency then inform the engineer
- The engineered infill must be placed and fully compacted in layers
- Building near trees in shrinkable soil can effect the raft design
- Avoid undermining the raft edges with drainage excavations etc.

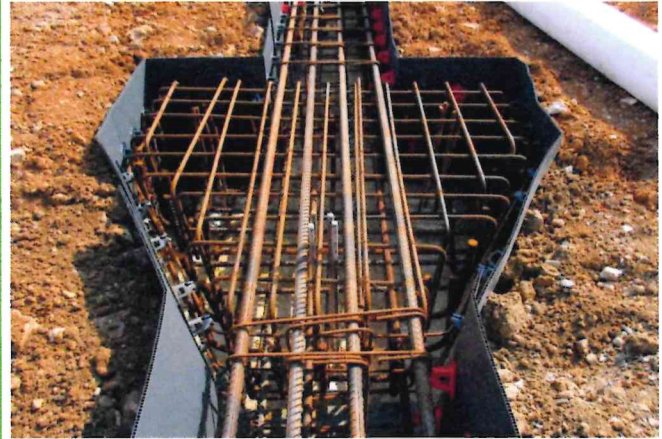
- The accuracy of the setting out is important
- Look out for misaligned or missing pile situations
- With shrinkable soils ensure that building near trees is considered
- Ensure that any heave precautions are properly installed

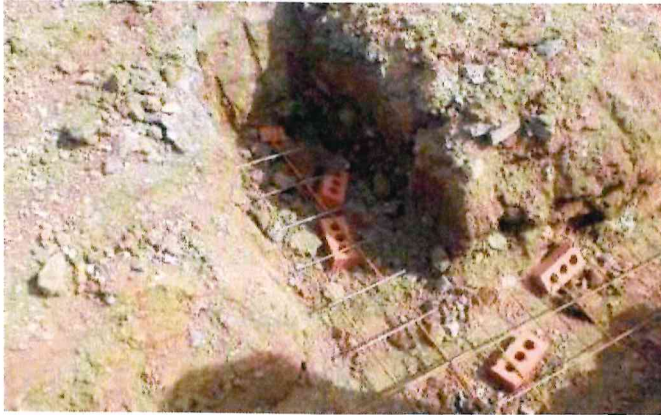
- Poor workmanship
- Hard spots created using clay bricks
- Risk of steel corrosion due to lack of coverage to reinforcement

- Unsuitable working practises
- Expensive claim if foundation fails
- Disruption to homeowner

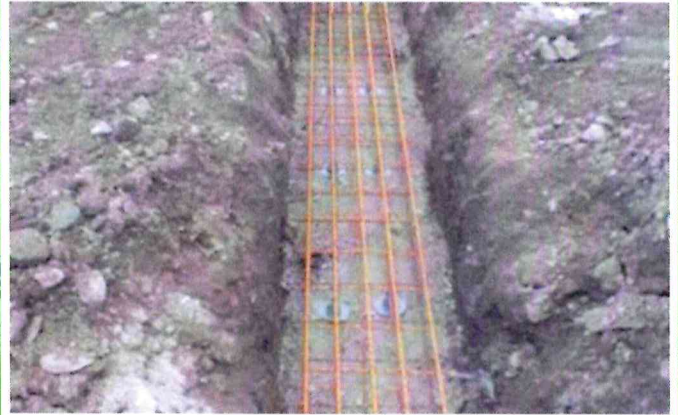
- Follow the design/details
- If the details are unclear then seek clarification
- Use the correct cover proprietary spacers
- The use of concrete blinding provides a suitable uniform base

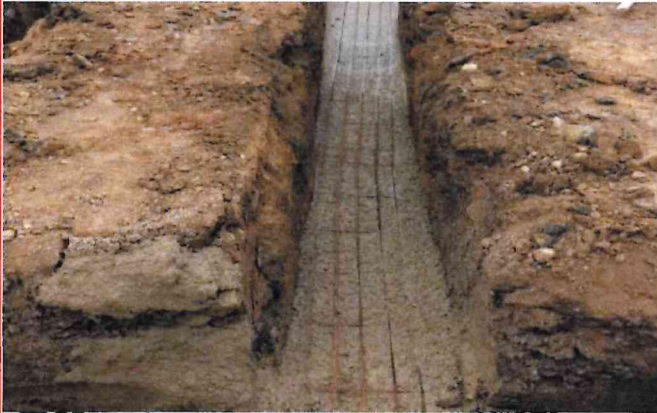
- Water in excavation
- Cold weather working
- Risk of steel corrosion due to lack of coverage to reinforcement

- Unsuitable working practises
- Expensive claim if foundation fails
- Strength and durability not as design intended due to wrong concrete mix ordered/used

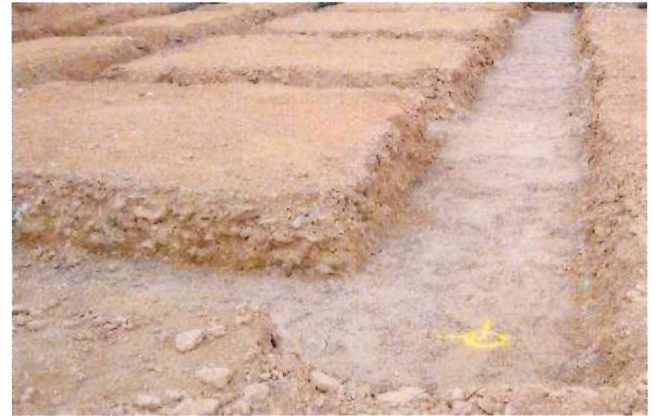
- Follow the design/details
- If the details are unclear then seek clarification
- Use the correct cover proprietary spacers
- The use of concrete blinding provides a suitable uniform base

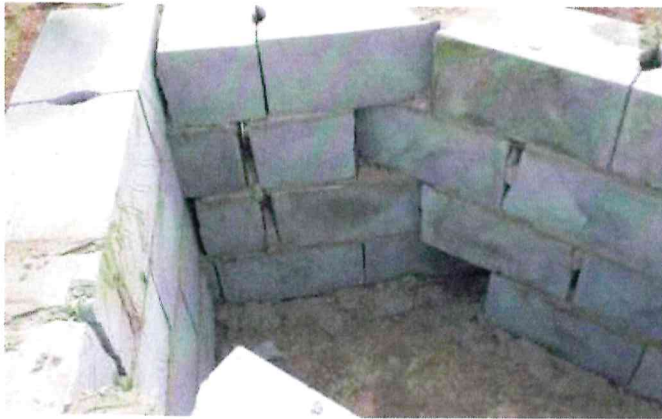
- Lack of effective bonding
- Hungry mortar joints
- Very poor workmanship

- Structural stability compromised
- Risk of vermin entry
- Strength and durability not as design intended due to wrong concrete mix ordered/used

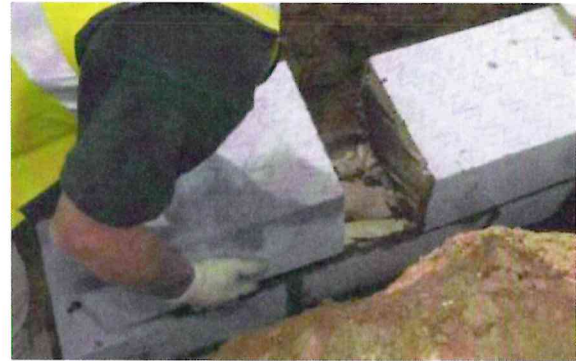
- Use the materials specified in the design with reference to:
 - block/brick strength
 - sulphate resisting blocks/bricks
 - mortar strength/sulphate resisting etc.
- Ensure that the setting out (both line and level) is accurate and adhered to
- Ensure mortar beds & joints are fully filled

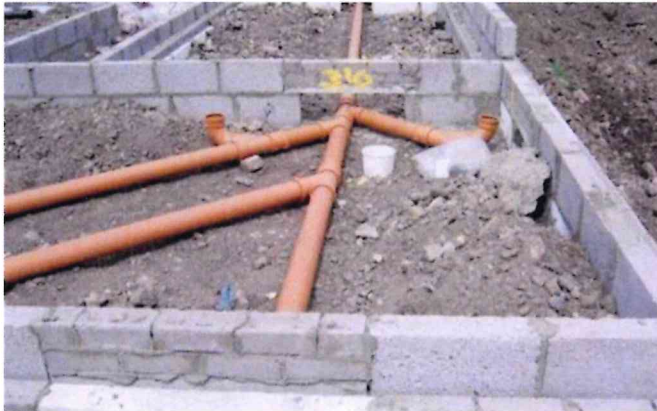
Key issues

- Design not followed
- Incorrect use of Y-junction below the ground floor
- Minimum gradient not achieved

- Higher risk of blockages
- Delays to the build process
- Dissatisfaction to homeowner

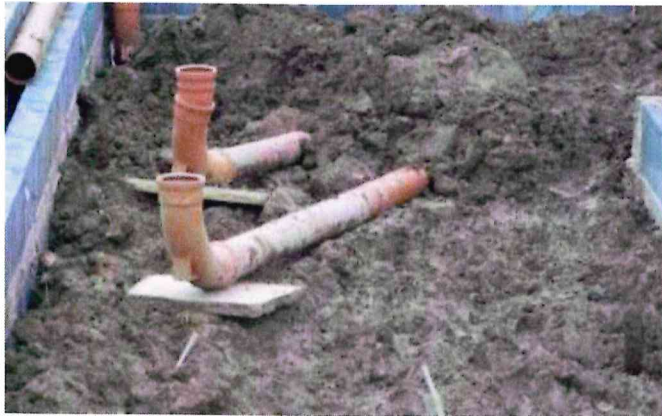
- Inaccurate positioning
- Incorrect bedding material
- Temporary caps not used

- Higher risk of blockages
- Disruptive remedial work
- Potential damage to DPM

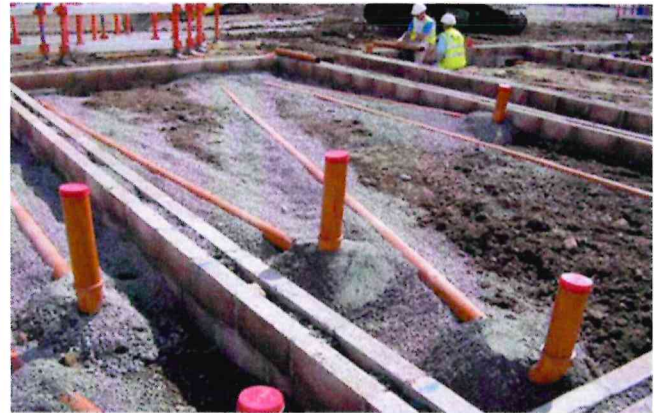
- Pipe locations require setting out accurately
- Use rest bends and secure into position
- Fit temporary caps for protection
- Drainage layouts must be followed

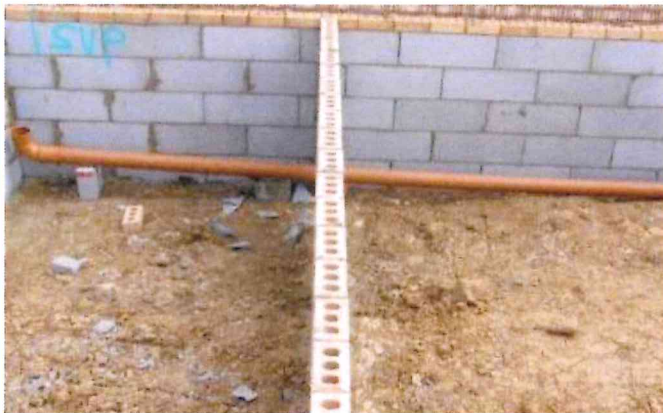
Key issues

- Pipework not placed on bedding gravel
- Block used to create fall
- Incorrect materials used

- Unsuitable bedding can damage pipes
- Disruptive and very expensive remedial work required when there are back falls to drainage below groundfloor

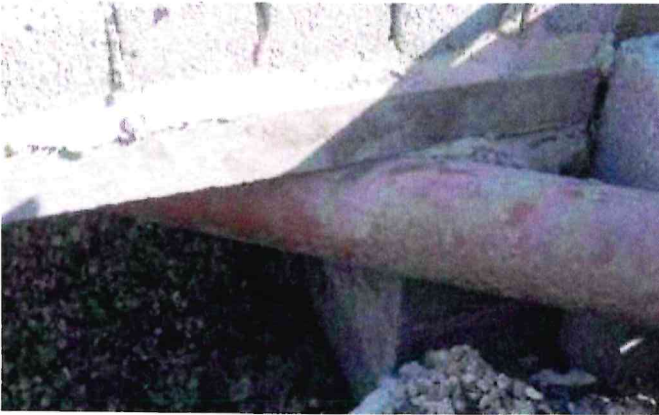
- Pipework not placed on bedding gravel
- Block used to create fall
- Incorrect materials used

- Unsuitable bedding can damage pipes
- Disruptive and very expensive remedial work required when there are back falls to drainage below groundfloor

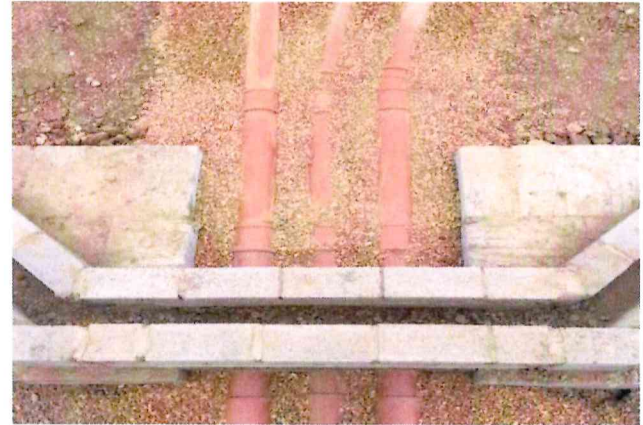
- Co-ordinate service penetrations with the masonry substructure activity
- The following are acceptable:
 - lintelled opening
 - pipe built in with flexible joints either side of the wall

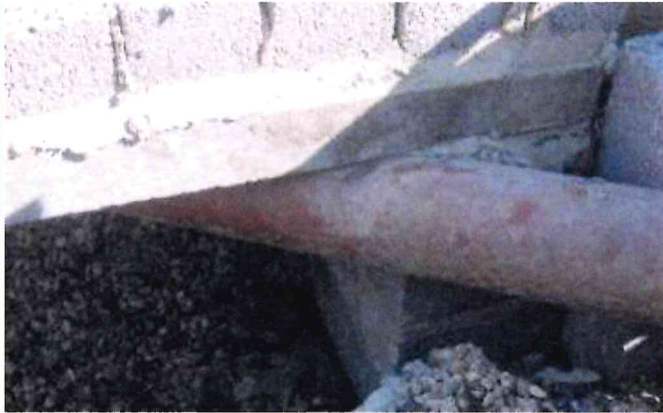
- Pipework not placed on bedding gravel
- Block used to create fall
- Incorrect materials used

- Unsuitable bedding can damage pipes
- Disruptive and very expensive remedial work required when there are back falls to drainage below groundfloor

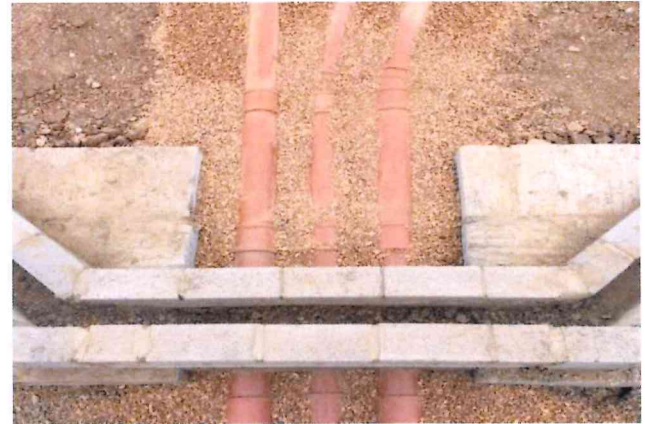
- Co-ordinate service penetrations with the masonry substructure activity
- The following are acceptable:
 - lintelled opening
 - pipe built in with flexible joints either side of the wall

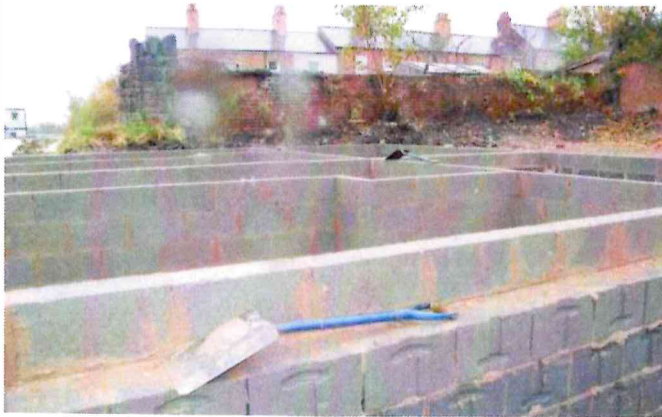
Key issues

- Lack of awareness of fill limits
- Fill exceeding 600mm
- Lack of compaction of engineered fill

- Failure of the ground floor
- Risk of heave from near by trees
- Disruption to homeowner

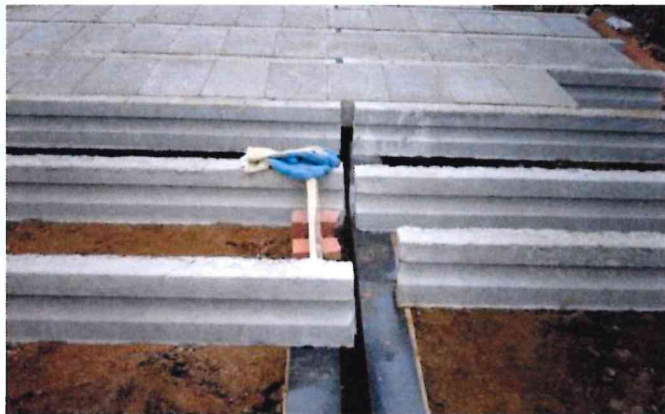
Key issues

- Incorrect bearing of beams
- Beams protruding into the cavity
- Lack of precaution against heave

- Failure of the ground floor
- Damage drainage
- Disruption to homeowner

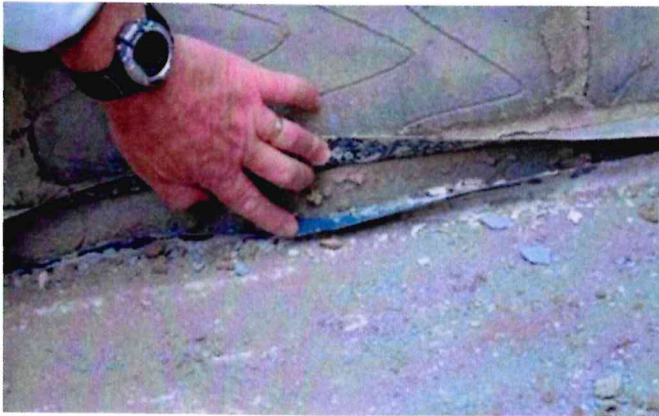
- Incorrect bearing of beams
- Beams protruding into the cavity
- Lack of precaution against heave

- Failure of the ground floor
- Damage drainage
- Disruption to homeowner

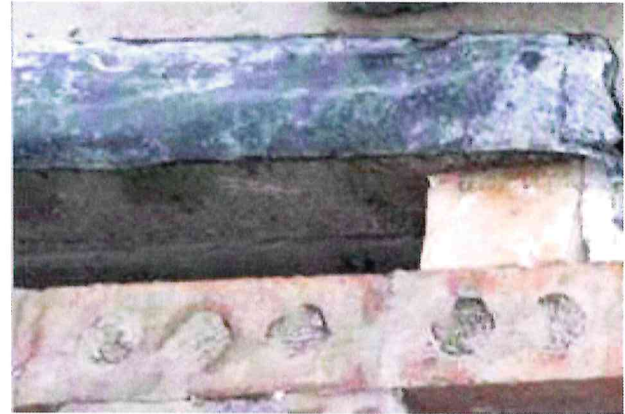
- Use smooth blinding material to protect the DPM
- Ensure that there is sufficient DPM material to link with the DPC
- Attention to detail at corners and service penetrations is important

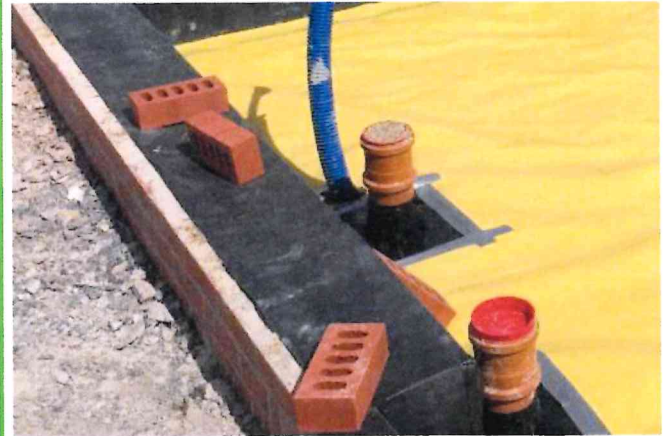
- Use the materials specified in the design
- Follow the design/details
- If the details are unclear then seek clarification
- Preformed internal/external corners are available and work well

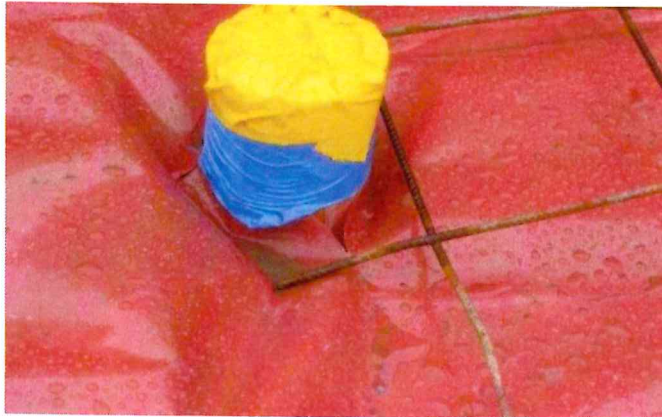
- Lack of understanding from worker
- Design not followed
- Gas entering into the property

- Radon barrier not continuous is a human health risk (**Radon can cause cancer**)
- Risk of asphyxiation/explosion with some gasses (CO₂/Methane)

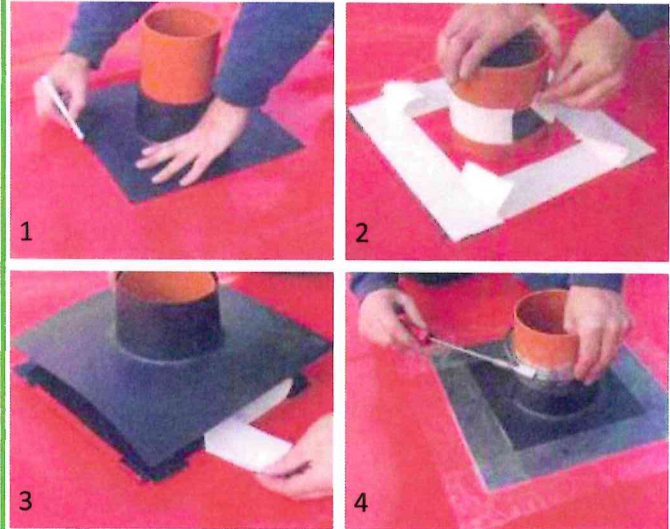
- Use the materials specified in the design
- Attention to detail at corners and service penetrations is important
- Proprietary products provide effective solutions

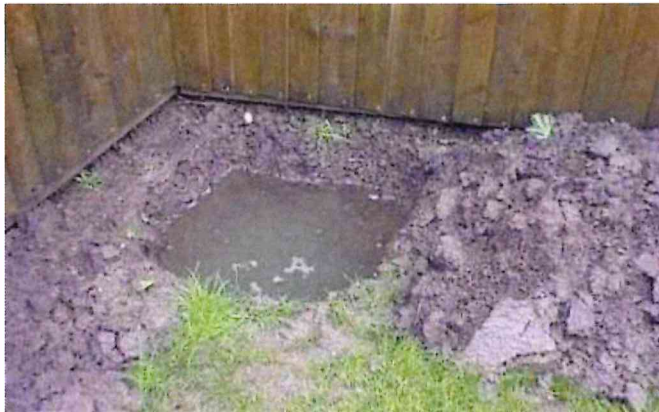
- Incorrect soils for the use of a soak away
- Lack of percolation test being undertaken

- Surface water drain backing up
- Water logging in the garden areas
- Sited too close to footings can cause damage foundations

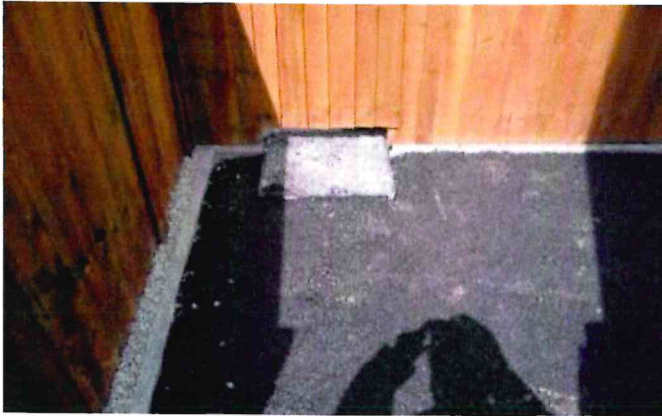
- Unable to gain access to the chamber
- Raised cover may provide trip hazard

- Access for rodding may become difficult
- Chamber/property may be damaged
- Disatisfaction to homeowner

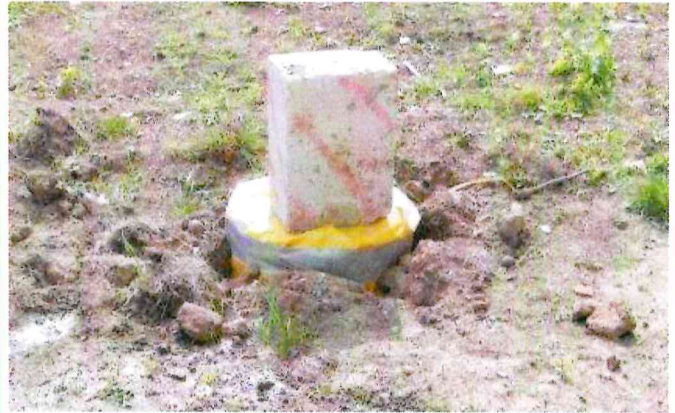
- Use the materials/products specified in the design
- Set out accurately avoiding boundaries/ kerb lines
- Set covers at correct level relative to adjacent finished ground/surface
- Protect covers from damage during the construction phase

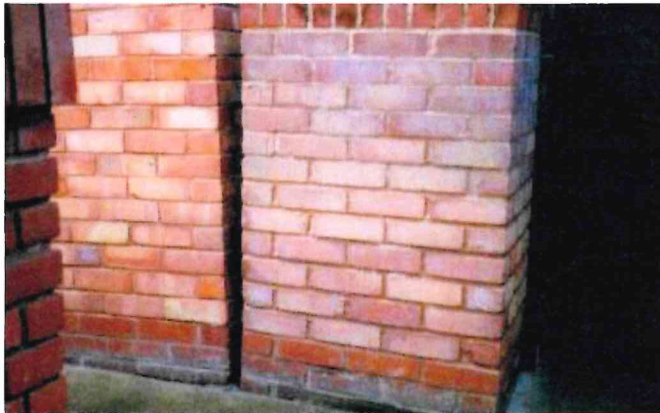
- Design not followed
- Inadequate foundation
- Lack of site control

- Durability issues with poor detailing
- Building near trees may cause instability

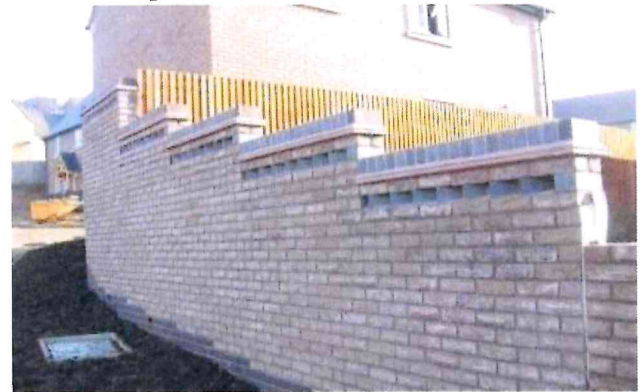
- Follow the design details
- Avoid ad-hoc construction
- The following are all important if failure is to be avoided:
 - concrete foundation
 - above and below DPC brick suitability
 - damp proof courses
 - capping/coping detail
 - expansion joints

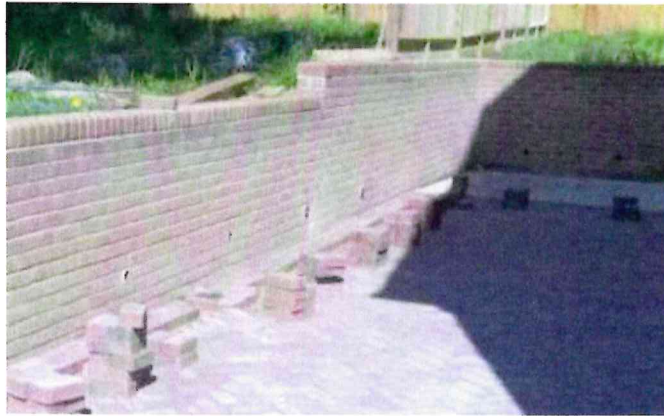
- No guarding provided
- Heightened risk of falls

- Risk of injury
- Potential delays at Pre-handover

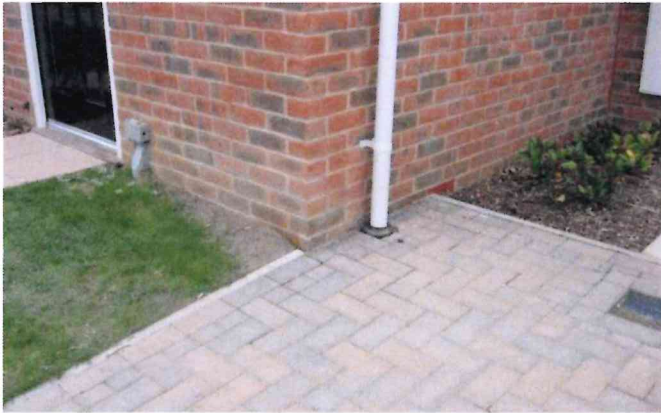
Key issues

- External ground levels not 150mm below DPC
- Risk of soaking walls above DPC

- Moisture ingress above the ground floor
- Dissatisfaction to the homeowner

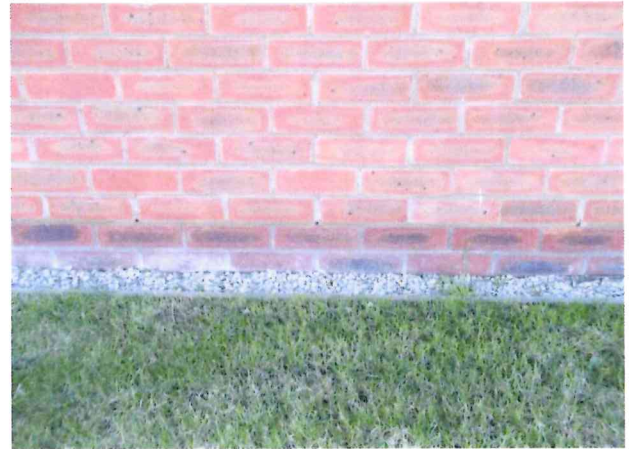
- The paving and ground levels need to take account of the DPC level
- If the DPC level is not clear then seek clarification
- Take extra care with sloping sites
- The projection of the DPC will assist with its identification

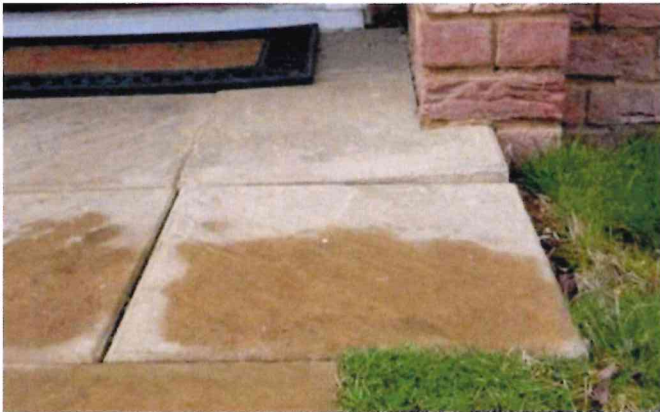
- Poor sub base leading settlement issues
- Poor workmanship associated with setting and cutting

- Trip hazards formed within the home
- Aesthetically poor
- Dissatisfaction to homeowner

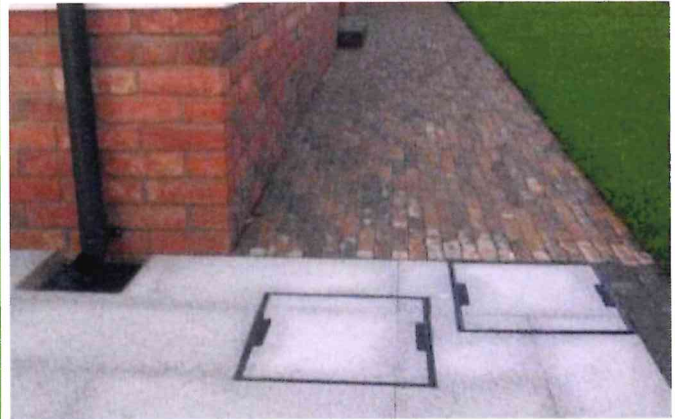
- Use a suitable sub-base which should be 100mm thick
- The sub-base should be well consolidated
- 1:4 cement: sand mortar is a suitable bedding mix for paving slabs
- Neat cutting will add to the overall appearance

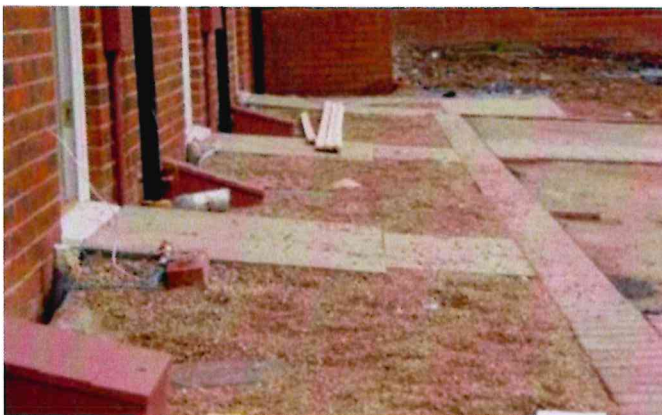
- Unsuitable landings
- Maximum gradient exceeded
- Minimum width not achieved

- Delays at Pre-handover
- Non-compliance with Building Regs
- Disruption to homeowner

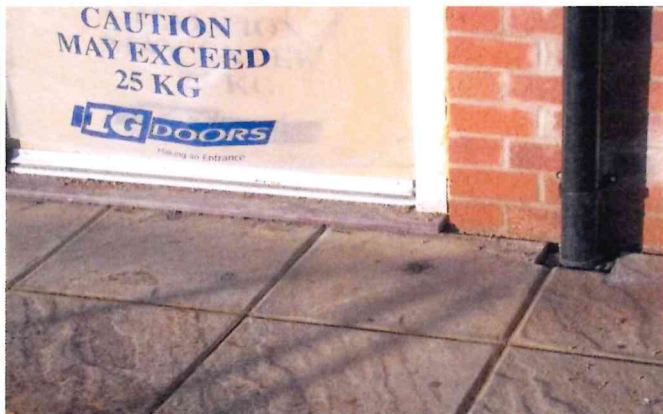
- Potential for water ingress
- Trip hazard
- Potential for standing water to freeze

- Delays at Pre-handover
- Non-compliance with Building Regs
- Disruption to homeowner

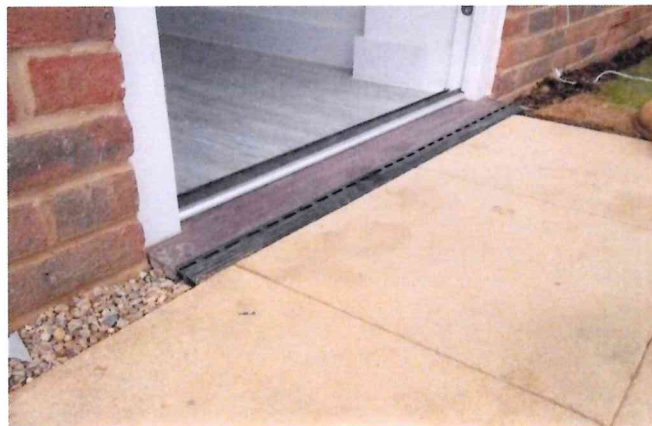
- Follow the design details
- Where the details are unclear seek clarification
- Use a drainage slot or channel in all but the most sheltered locations
- Avoid creating a trip hazard between the path/channel and the frame sill

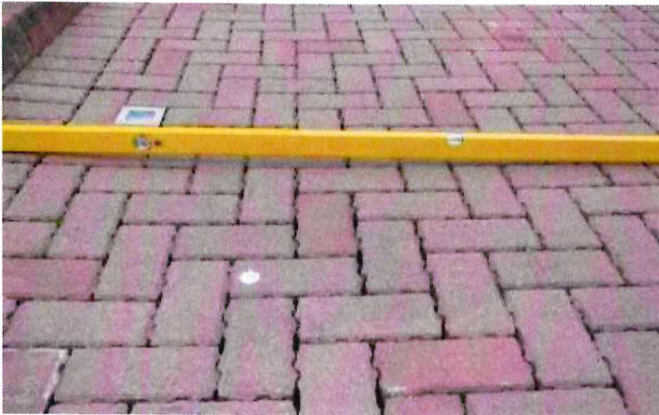
- Poor sub base leading to settlement
- Areas prone to ponding could become hazardous during freezing temperatures

- Poor visual appearance
- Potential drainage issues

- Surface variations should not exceed +/- 10mm with 2m straight edge
- Temporary standing water is not permitted adjacent to entrance doors
- The maximum drive gradient is 1:6
- Where drive gradients are more than 1:10 transition lengths are required
