OUT OF TOLERANCE PILE REMEDIATION

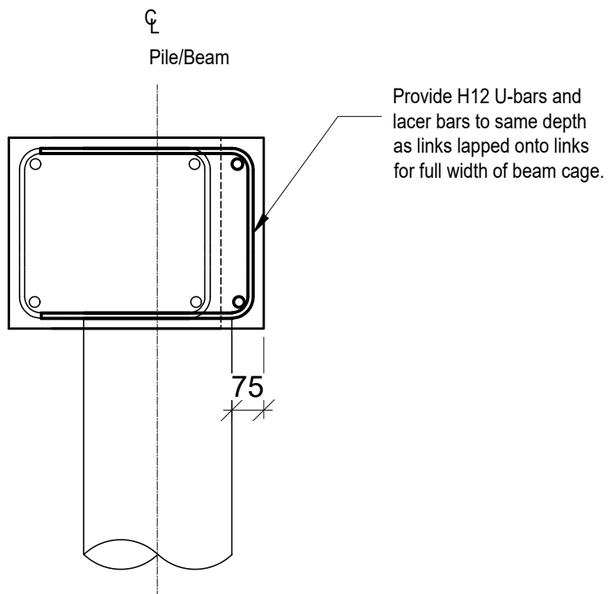
Detail A

Typical Ground Beam Remedial Detail - Pile displaced laterally

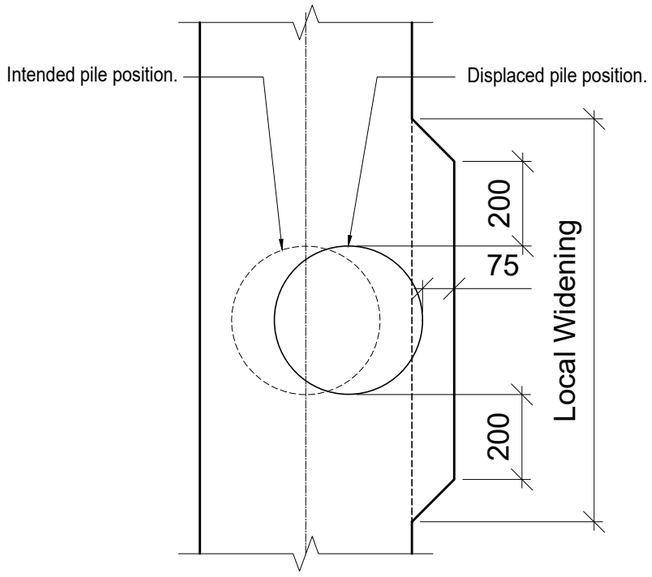
Detail B

Typical Ground Beam Remedial Detail - Pile displaced longitudinally
