Drainage Report

Milton Parking
Gas Road
Sittingbourne
Kent
ME10 2QB

Milton Parking Gas Road - CCTV Survey Report : 20/06/25

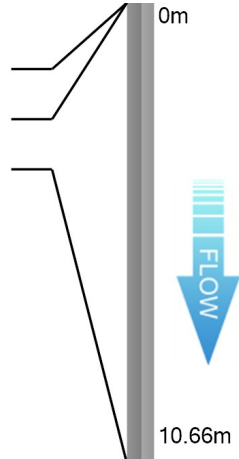
Structural Peak Grade	0	Operational Grade	0	DRB Grade	A
-----------------------	---	-------------------	---	-----------	---

Position	Code	Description	CD	Pic	Video Ref	
00.0	MH	Start node type, manhole		0_0	0:00:00	
00.0	WL	Water level 0%		0_1	0:00:00	
10.7	MHF	Finish node type, manhole		0_9

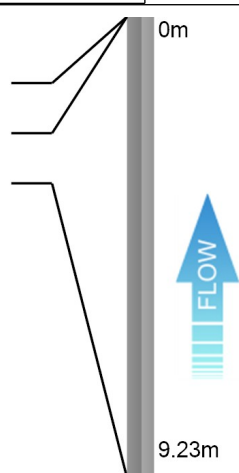
Structural Peak Grade	0	Operational Grade	0	DRB Grade	A
-----------------------	---	-------------------	---	-----------	---

Position	Code	Description	CD	Pic	Video Ref	
00.0	MH	Start node type, manhole		5_0	0:00:00

00.0	WL	Water level 0%		5_1	0:00:00	
09.2	MHF	Finish node type, manhole		5_9

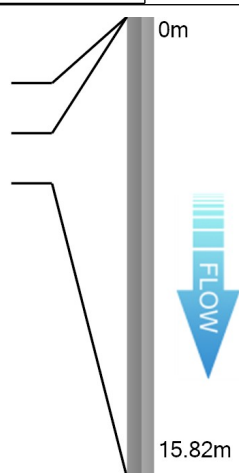
Structural Peak Grade	0	Operational Grade	0	DRB Grade	A
-----------------------	---	-------------------	---	-----------	---

Position	Code	Description	CD	Pic	Video Ref	
00.0	MH	Start node type, manhole		1_0	0:00:00	
00.0	WL	Water level 0%		1_1	0:00:00	
15.8	MHF	Finish node type, manhole		1_9

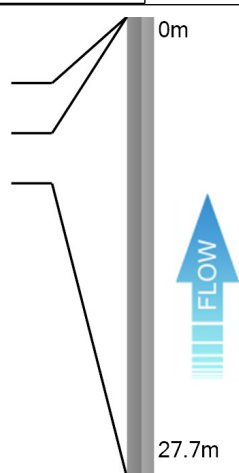
Structural Peak Grade	0	Operational Grade	0	DRB Grade	A
-----------------------	---	-------------------	---	-----------	---

Position	Code	Description	CD	Pic	Video Ref	
00.0	MH	Start node type, manhole		4_0	0:00:00

00.0	WL	Water level 0%		4_1	0:00:00	
27.7	MHF	Finish node type, manhole		4_9

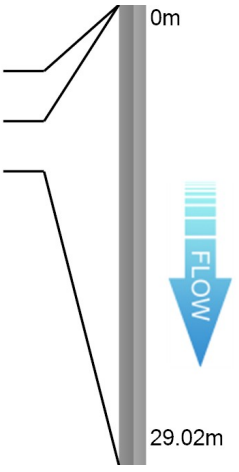
Structural Peak Grade	0	Operational Grade	0	DRB Grade	A
-----------------------	---	-------------------	---	-----------	---

Position	Code	Description	CD	Pic	Video Ref	
00.0	MH	Start node type, manhole		6_0	0:00:00

00.0	WL	Water level 0%		6_1	0:00:00	
29.0	MHF	Finish node type, manhole		6_9

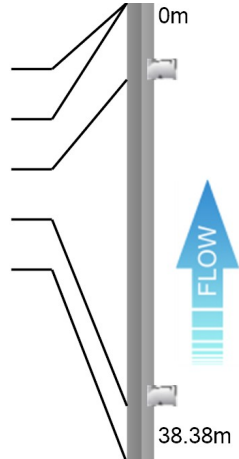
Structural Peak Grade	0	Operational Grade	0	DRB Grade	A
-----------------------	---	-------------------	---	-----------	---

Position	Code	Description	CD	Pic	Video Ref	
00.0	MH	Start node type, manhole		9_0	0:00:00	
00.0	WL	Water level 0%		9_1	0:00:00	
06.4	CN	Connection other than junction 10 : 150mm		9_2	0:00:25	
33.6	CN	Connection other than junction 10 : 150mm		9_3	0:01:49	
38.4	MHF	Finish node type, manhole		9_9

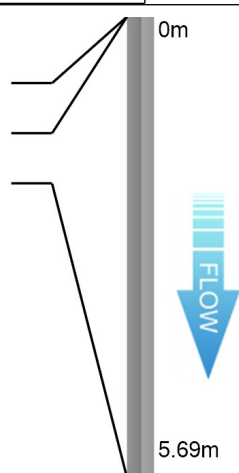
Structural Peak Grade	0	Operational Grade	0	DRB Grade	A
-----------------------	---	-------------------	---	-----------	---

Position	Code	Description	CD	Pic	Video Ref	
00.0	MH	Start node type, manhole		10_	0:00:00

00.0	WL	Water level 0%		10_	0:00:00	
05.7	MHF	Finish node type, manhole		10_

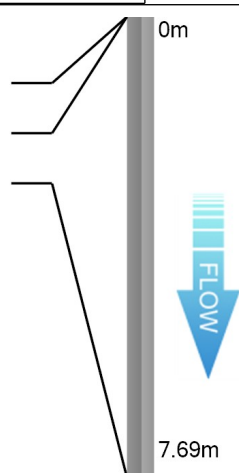
Structural Peak Grade	0	Operational Grade	0	DRB Grade	A
-----------------------	---	-------------------	---	-----------	---

Position	Code	Description	CD	Pic	Video Ref	
00.0	MH	Start node type, manhole		11_	0:00:00

00.0	WL	Water level 0%		11_	0:00:00	
07.7	MHF	Finish node type, manhole		11_

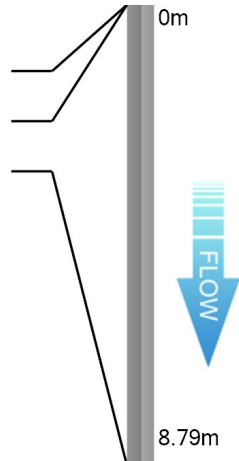
Structural Peak Grade	0	Operational Grade	0	DRB Grade	A
-----------------------	---	-------------------	---	-----------	---

Position	Code	Description	CD	Pic	Video Ref	
00.0	MH	Start node type, manhole		12_	0:00:00

00.0	WL	Water level 0%		12_	0:00:00	
08.8	MHF	Finish node type, manhole		12_

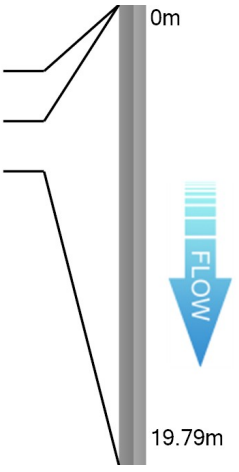
Structural Peak Grade	0	Operational Grade	0	DRB Grade	A
-----------------------	---	-------------------	---	-----------	---

Position	Code	Description	CD	Pic	Video Ref	
00.0	MH	Start node type, manhole		13_	0:00:00

00.0	WL	Water level 0%		13_	0:00:00	
19.8	MHF	Finish node type, manhole		13_

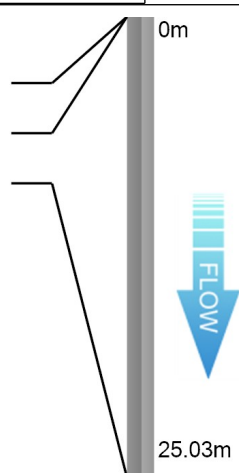
Structural Peak Grade	0	Operational Grade	0	DRB Grade	A
-----------------------	---	-------------------	---	-----------	---

Position	Code	Description	CD	Pic	Video Ref	
00.0	MH	Start node type, manhole		14_	0:00:00

00.0	WL	Water level 0%		14_	0:00:00	
25.0	MHF	Finish node type, manhole		14_

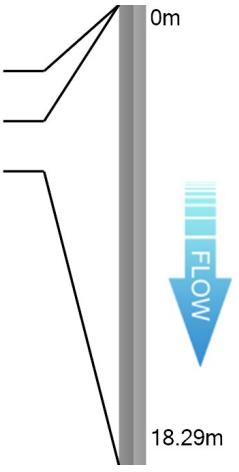
Structural Peak Grade	0	Operational Grade	0	DRB Grade	A
-----------------------	---	-------------------	---	-----------	---

Position	Code	Description	CD	Pic	Video Ref	
00.0	MH	Start node type, manhole		15_	0:00:00

00.0	WL	Water level 0%		15_	0:00:00	
18.3	MHF	Finish node type, manhole		15_
