Drainage Report

Clarus Homes
Bears Green Plot 2 - Bears Lane
Great Chart, Bethersden, Ashford
Kent
TN23 3BZ

Clarus Homes Bears Lane PLOT 2 - CCTV Survey Report : 10/07/25

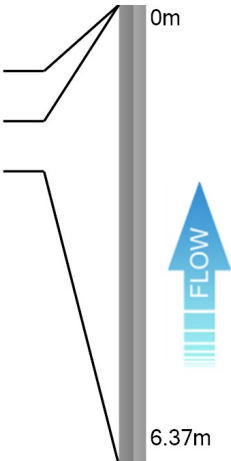
Section 1

Structural Peak Grade	0	Operational Grade	0	DRB Grade	A
-----------------------	---	-------------------	---	-----------	---

00.0	WL	Water level 0%		0_1	0:00:00	
06.4	MHF	Finish node type, manhole		0_9

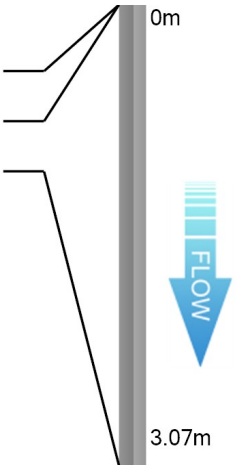
Section 2

Structural Peak Grade	0	Operational Grade	0	DRB Grade	A
-----------------------	---	-------------------	---	-----------	---

00.0	WL	Water level 0%			0:00:00	
03.1	MHF	Finish node type, manhole		7_9

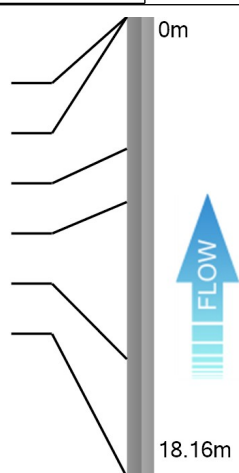
Structural Peak Grade	0	Operational Grade	0	DRB Grade	A
-----------------------	---	-------------------	---	-----------	---

Position	Code	Description	CD	Pic	Video Ref	
00.0	MH	Start node type, manhole		2_0	0:00:00	
00.0	WL	Water level 0%		2_1	0:00:00	
05.2	REM	General remark		2_2	0:00:20	
07.3	REM	General remark		2_3	0:00:28	
13.5	REM	General remark		2_4	0:00:52	
18.2	MHF	Finish node type, manhole		2_9

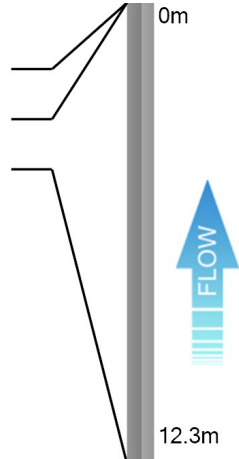
Structural Peak Grade	0	Operational Grade	0	DRB Grade	A
-----------------------	---	-------------------	---	-----------	---

Position	Code	Description	CD	Pic	Video Ref	
00.0	MH	Start node type, manhole		3_0	0:00:00	
00.0	WL	Water level 0%		3_1	0:00:00	
12.3	MHF	Finish node type, manhole		3_9

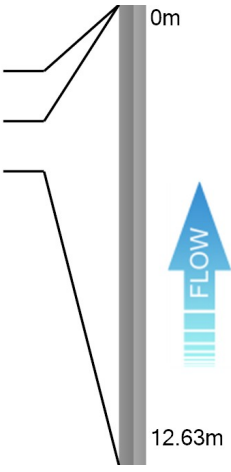
Structural Peak Grade	0	Operational Grade	0	DRB Grade	A
-----------------------	---	-------------------	---	-----------	---

00.0	WL	Water level 0%		4_1	0:00:00	
12.6	BRF	Finish node type, major connection without manhole		4_9

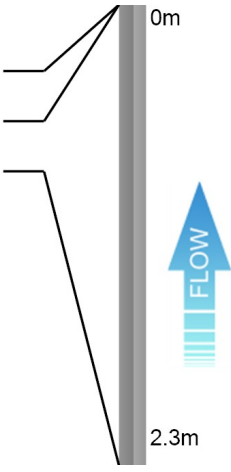
Structural Peak Grade	0	Operational Grade	0	DRB Grade	A
-----------------------	---	-------------------	---	-----------	---

00.0	WL	Water level 0%		5_1	0:00:00	
02.3	MHF	Finish node type, manhole		5_9

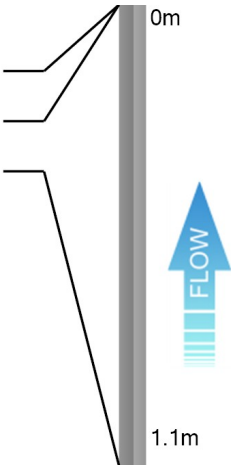
Structural Peak Grade	0	Operational Grade	0	DRB Grade	A
-----------------------	---	-------------------	---	-----------	---

00.0	WL	Water level 0%		6_1	0:00:00	
01.1	MHF	Finish node type, manhole		6_9
